Consultant's Advice Note – Bowden Hall - Tree Safety RevA

Doc No: CAN/01 RevA Pages 3

Structural Safety Assessment of Residual Sycamore Trees

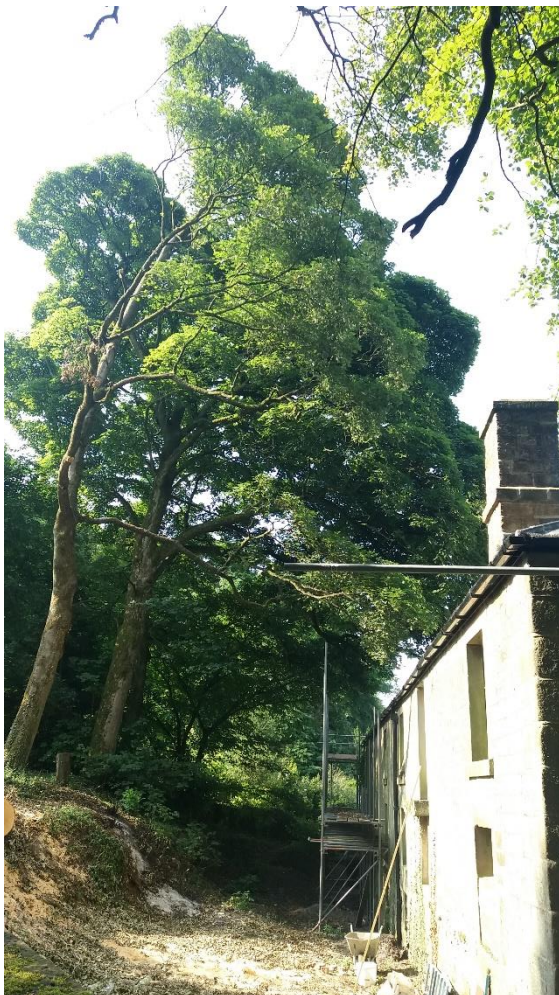
OBSERVATIONS ON SITE – originally there appears to have been a stand of 6 mature sycamore trees, of which only 1 now remains. As a result of the partial removal of the stand the one remaining tree is now more exposed to potential storm damage.

July 2023 photograph showing the trees location above and close to the hall. Root anchorages are inevitably compromised by the visible steep slope, believed once to have been faced in masonry.

CONCLUSIONS & RECOMMENDATIONS – There is a small but arguably significant risk to both listed fabric and human life during a storm event. As climate change accelerates it can also be argued that this risk will increase. The single remaining tree is also of limited value and could be replaced by planting several new trees, better located and using approved indigenous species.

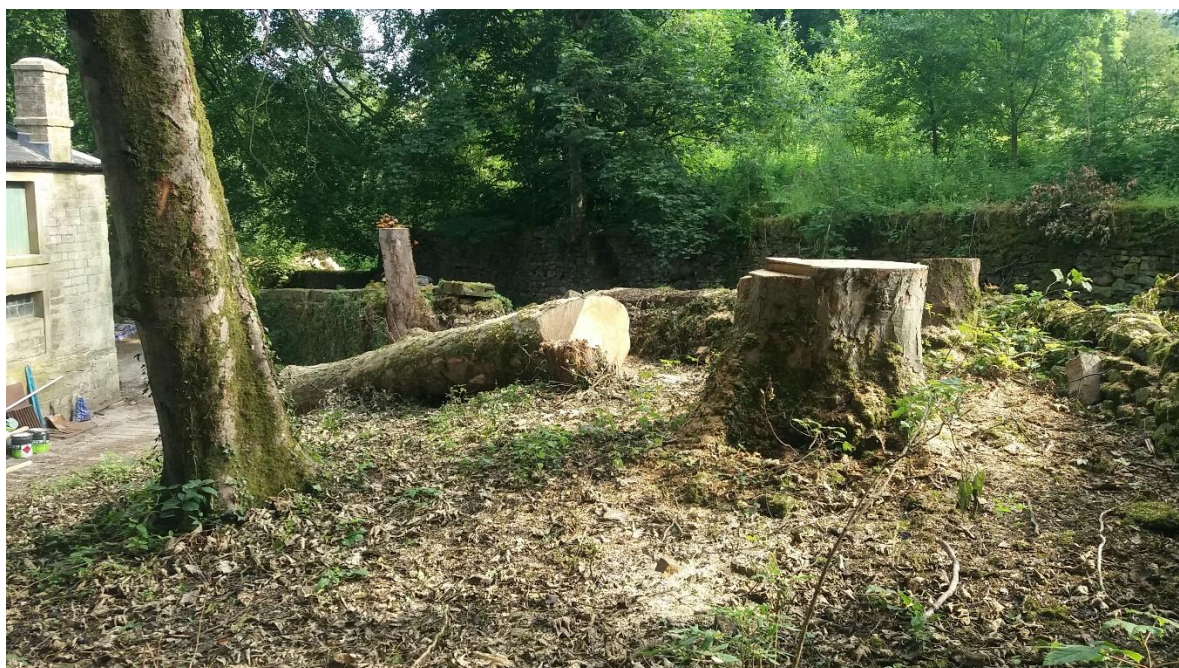
View looking north with the rear (NE corner) of the original hall building visible to the left

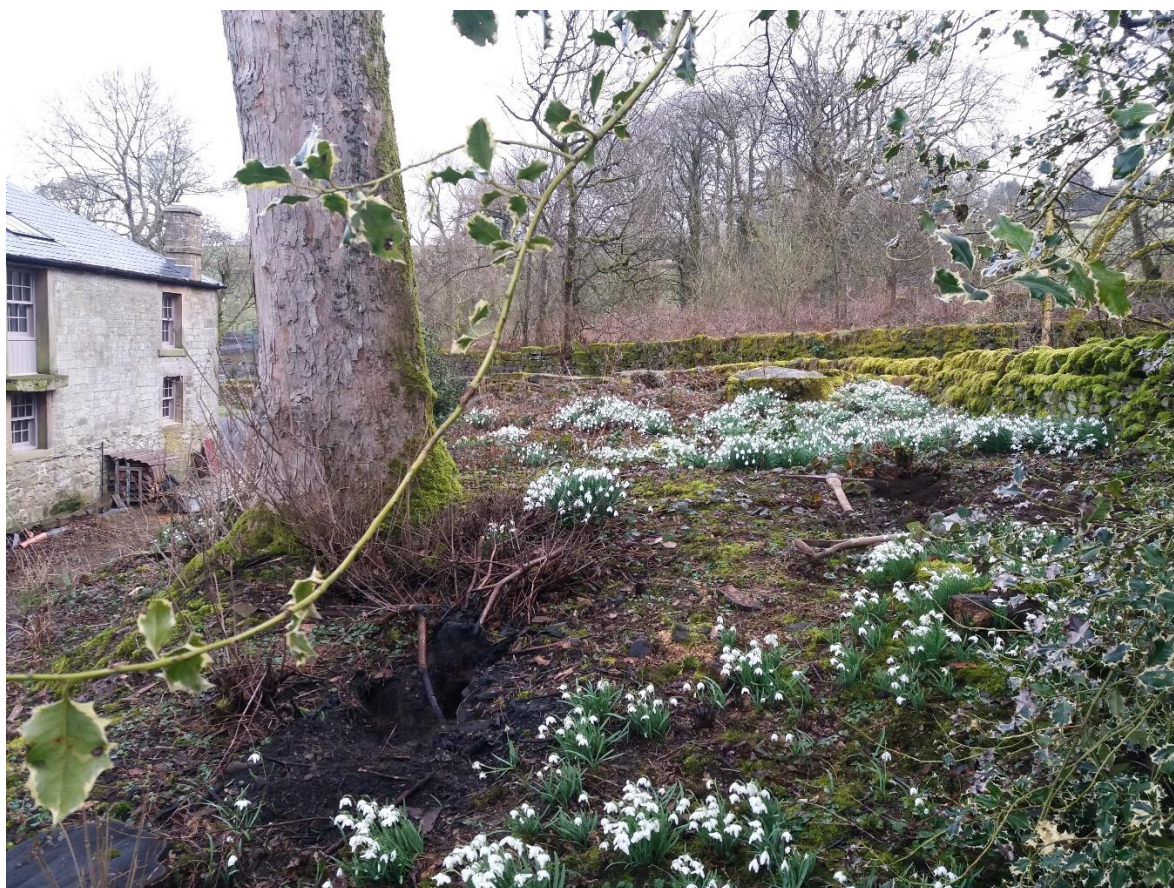
Trial pitting was also carried out in February 2023 following increased concern as to the integrity of the tree anchorage.

PREDICTED RESISTANCE – sycamores are renowned for their ability to resist high wind loads, however even under favourable conditions resistances are unlikely to be in excess of 600kNm. Reference to the British Geological Survey Map suggests that there are no significant superficial soil deposits overlying the site at Bowden, and that the bedrock consists of the Millstone Grit formation (mudstones, siltstones and sandstone). This has been verified on site during the 2023 trial pitting. It was observed that the ground was very difficult to excavate by hand due to the presence of well bedded sedimentary rock with only a marginal layer of topsoil. It is therefore considered reasonable to assume that the presence of shallow bedrock has restricted root penetration and adversely affected the potential root structure and anchorage of the residual tree.

Locations of trial pits dug in February 2023. Weak sedimentary bedrock was found at shallow depth.
