# FORMER GLOSSOPDALE COMMUNITY COLLEGE, TALBOT ROAD PLANNING APPEAL

HPK/2024/0481

PROOF OF EVIDENCE BY STELLA RIXON,  
BSc (HONS), MBPR

Date: 21 July 2026

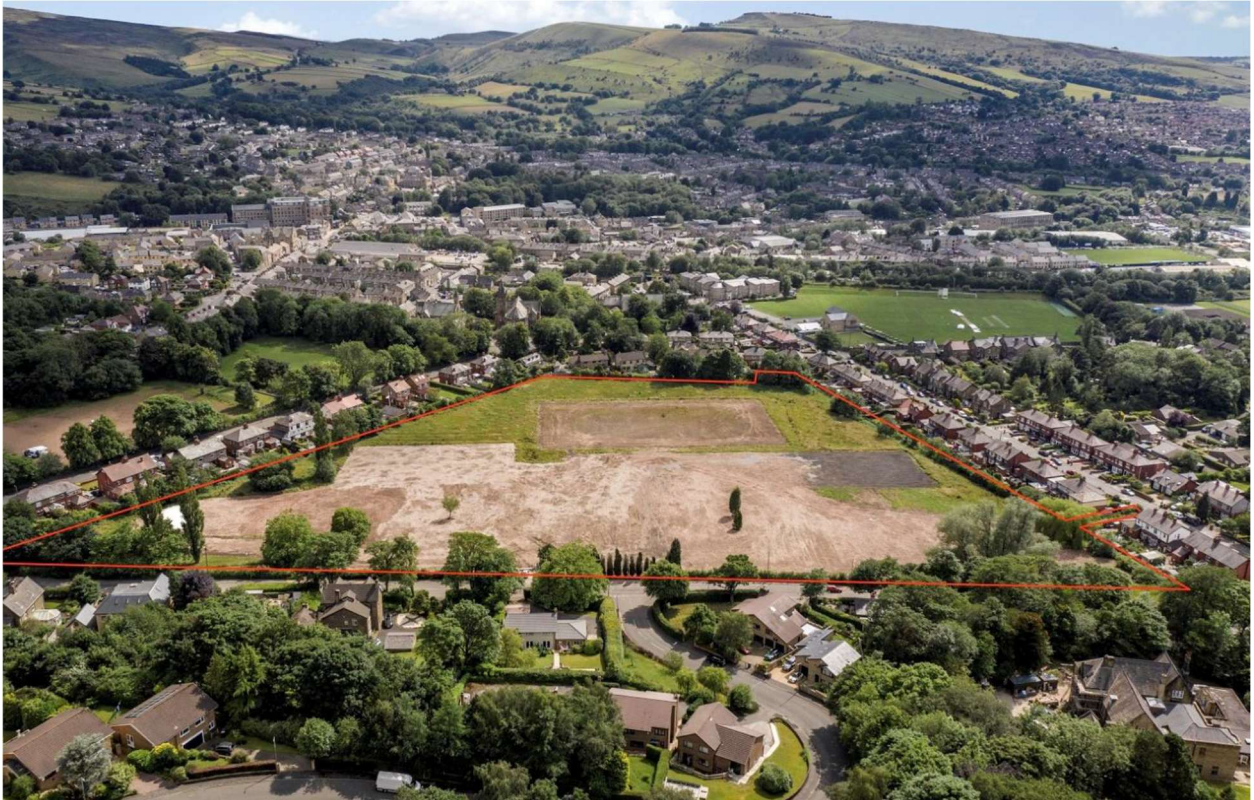
Figure C: Drone photograph courtesy of Derbyshire County Council of former Glossopdale Community College site post demolition (view south) shows much of the area is covered with demolition rubble.

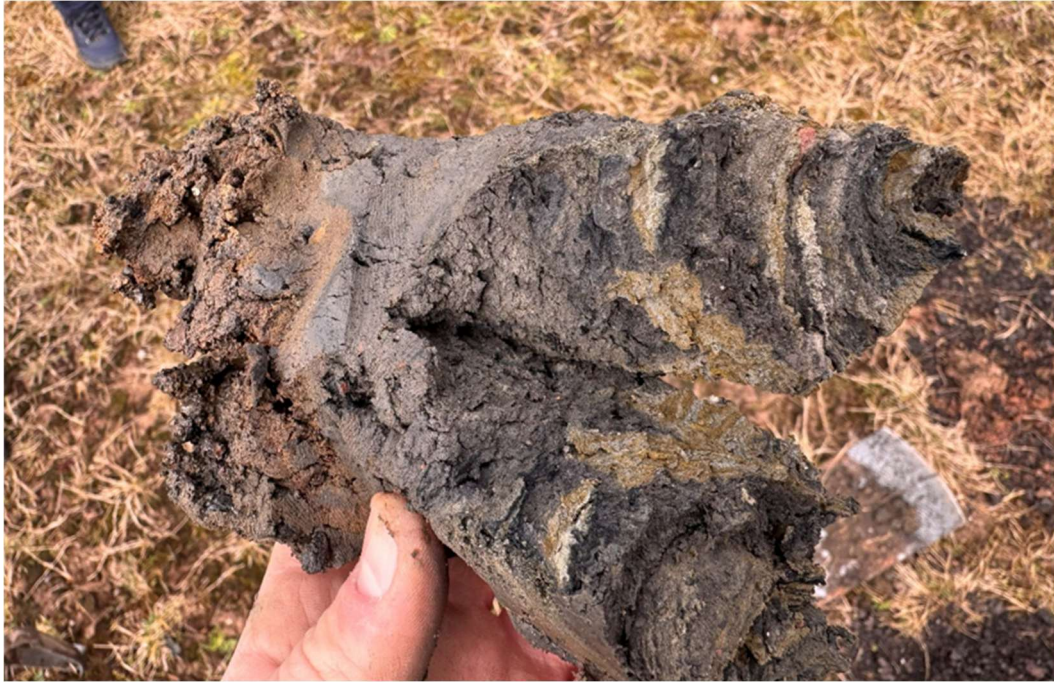
Photo 1: Trial pits around the site found brown clay loam in the topsoil and grey-brown heavy clay in the subsoil at 260-310mm depth with gleying present indicating prolonged saturation. Stone content was variable with some areas having high natural stone content, as well as brick/ demolition rubble.

- 2.16 Laboratory Particle Size Analysis (PSA) confirms that the topsoil analysed from the site falls into the clay loam textural classification. The soil has a high proportion of fine particles ('fines') comprising 11% very fine sand, 31% silt and 26% clay. The high proportion of fine particles (68%) and general particle size distribution suggests that the hydraulic conductivity of the topsoil is low and the soil has high-water holding capacity.

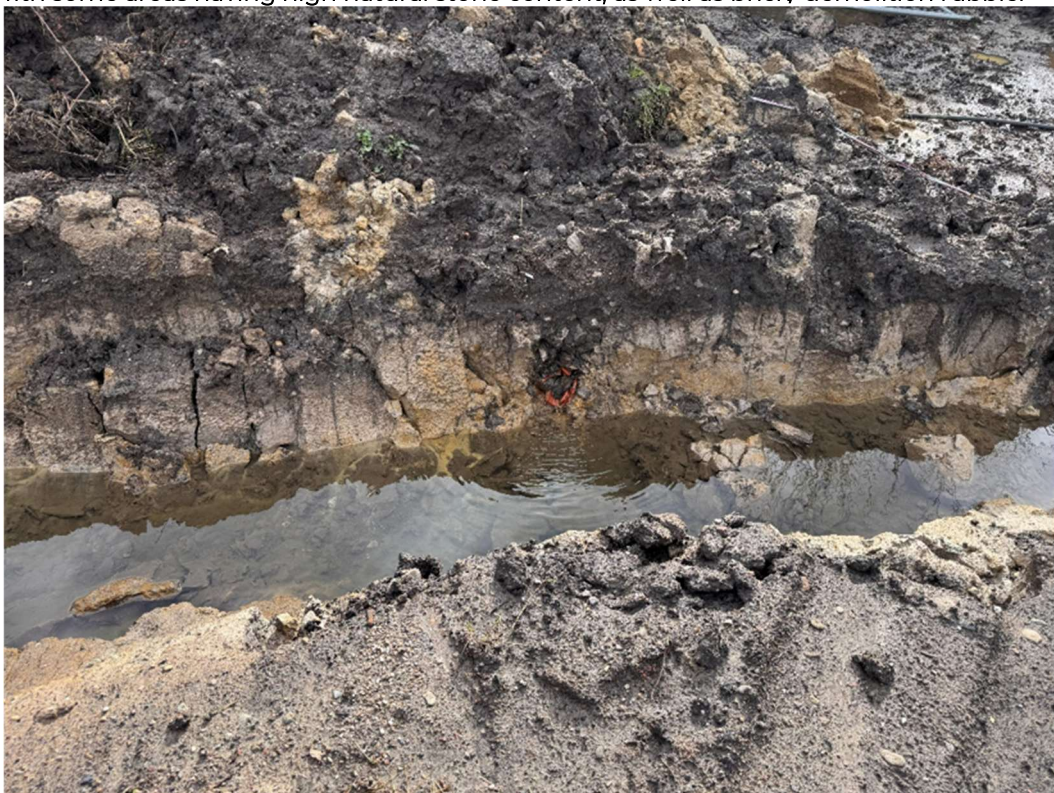
Photo 2: Drainage work (associated with neighbouring housing) on the SE corner of site shows the impervious underlying grey-brown clay that is holding surface water.

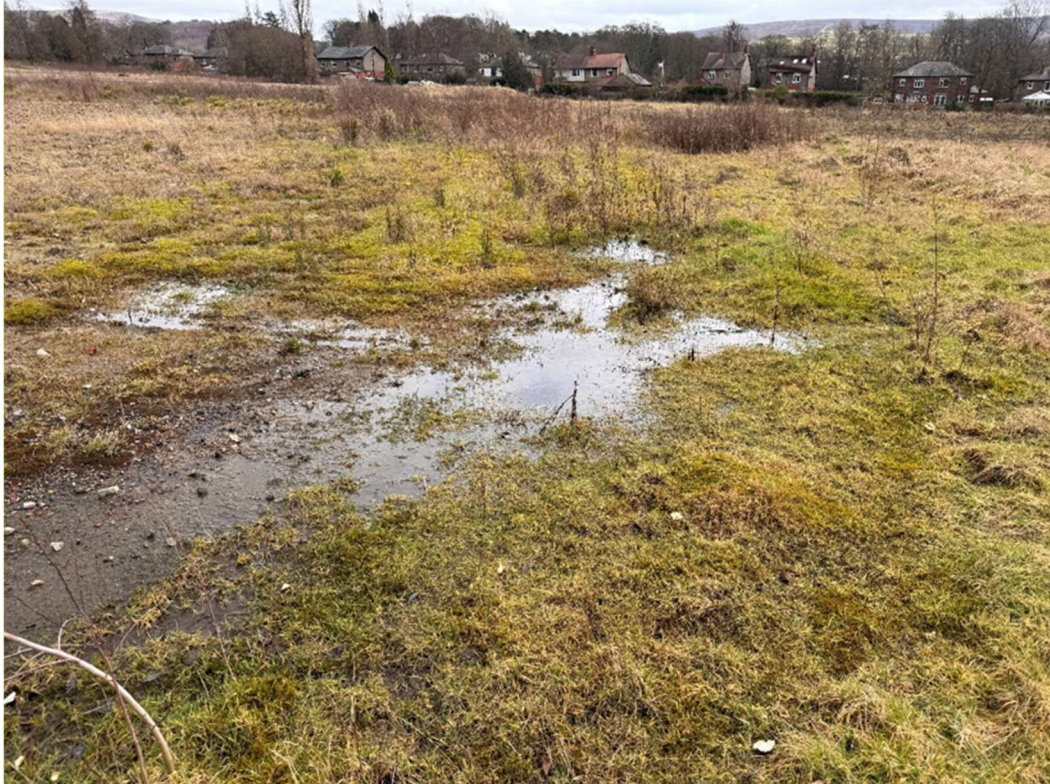
- 2.22 The poor draining nature of the soil was evident on the site with waterlogged areas observed and the topsoil in all the trial pits was wet with evidence of seasonal waterlogging and worm activity noted within the non-built on areas. It would be expected that the grassed areas would regularly become saturated and unsuitable for winter school use. This was highlighted by the surface water ponding observed during the site visit, as shown in Photo 3 below.
- 2.23 There is no known formal drainage such as pipe drains evident, other than drainage associated with the Redgra area which has inspection chambers along its southern edge.
- 2.24 The sloped topography allows the site to shed water downhill and therefore site drainage is better than its underlying soil type would allow. However, the site cannot

- 2.25** Without drainage, this soil type would have an infiltration rate of <5 mm/hr (as required to attain Sport England PQS) and a carrying capacity of less than 2hrs use/ week for ages >15yrs. In reality, there would be prolonged periods through the winter months that pitches would be unplayable without a suitably intensive and well-maintained sports pitch drainage system that would require ongoing investment.

Photo 3: Surface waterlogging on the west of the site at time of the visit (February 26).

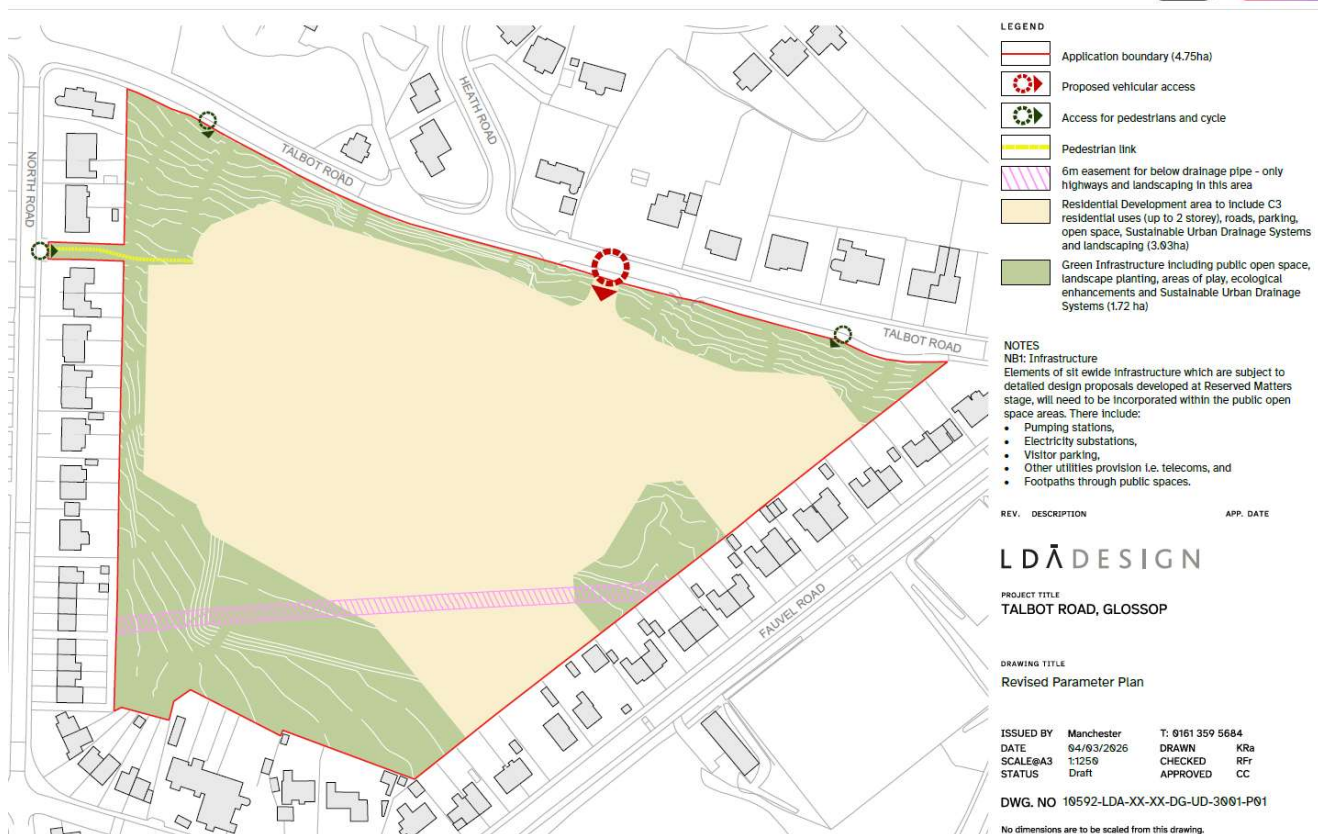
- 2.26** A culvert is noted on drawings of the site (Ref: LDA Design, copied below), identified in a utility survey search. The depth of this feature is not recorded but it is likely that it would potentially need to be re-routed, adding additional cost, if the site was to be levelled (via cut and fill) to accommodate SE compliant playing field area.

Figure E: Site development drawings show a culvert marked through the southern section of the site (shown in pink). This would need to be taken into account if releveling the land for sports use.

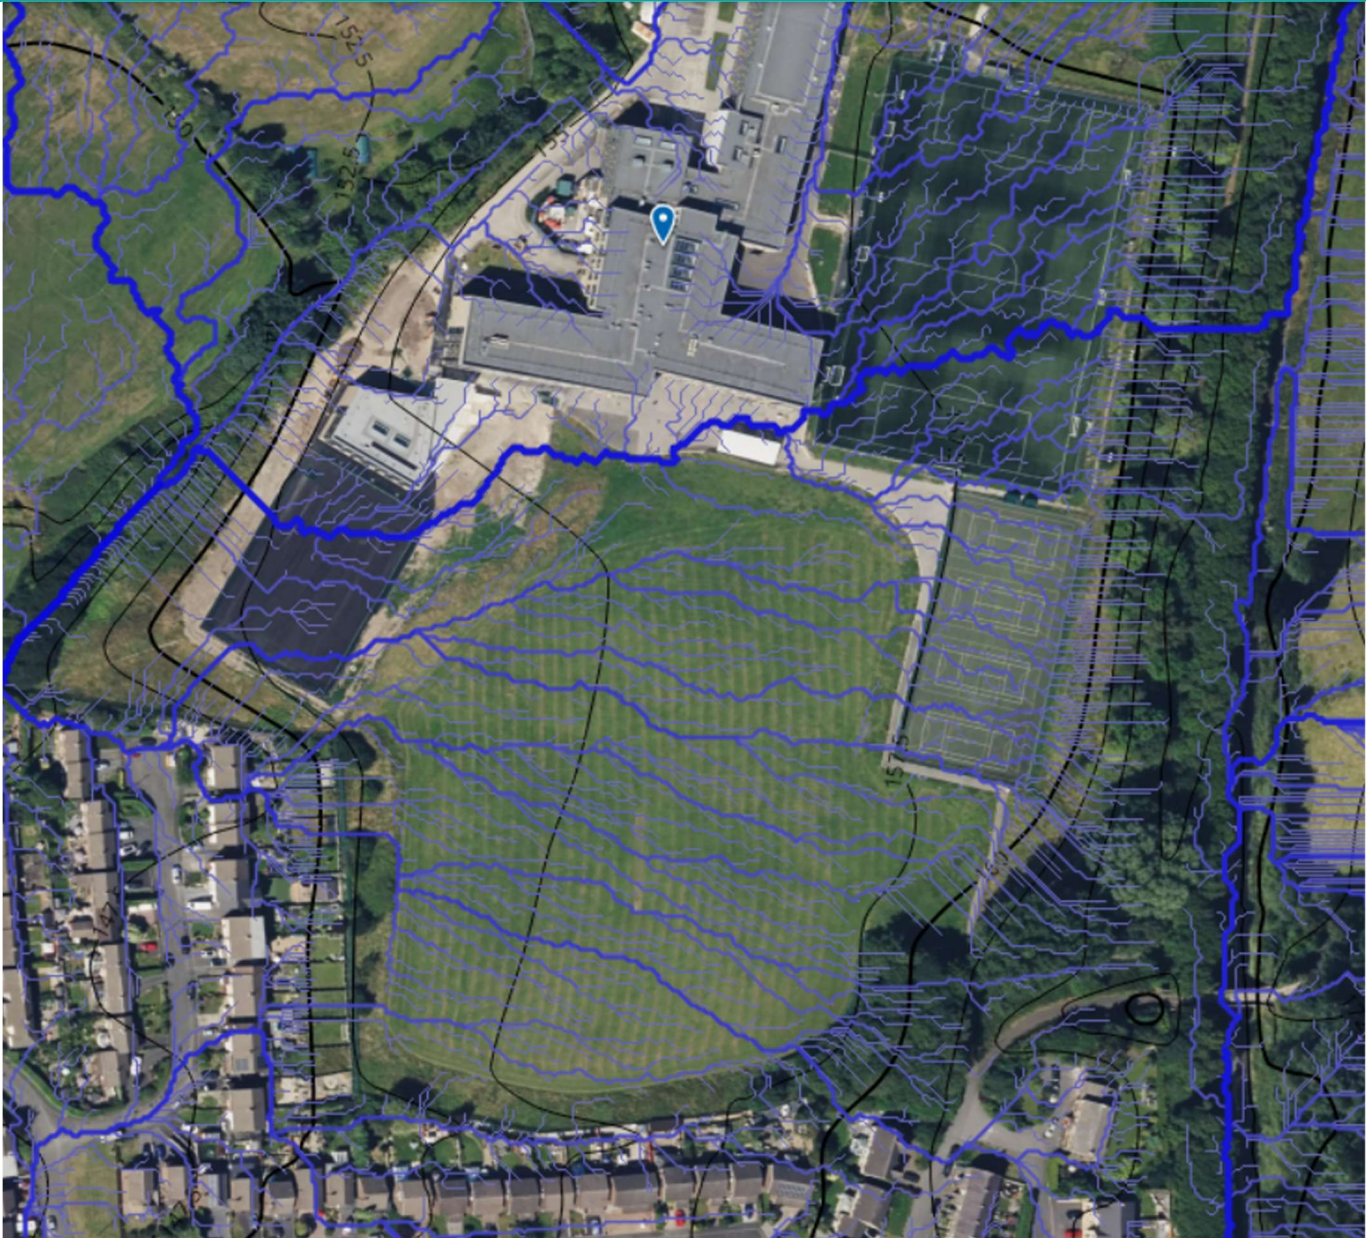
*Figure 5 – Surface water mapping using Scalgo shows surface water flow across the site flowing from the east to the west down with the natural fall of the land. The surface water flood risk on the MUGA comes from flow from higher ground and woodland to the NE of site.*

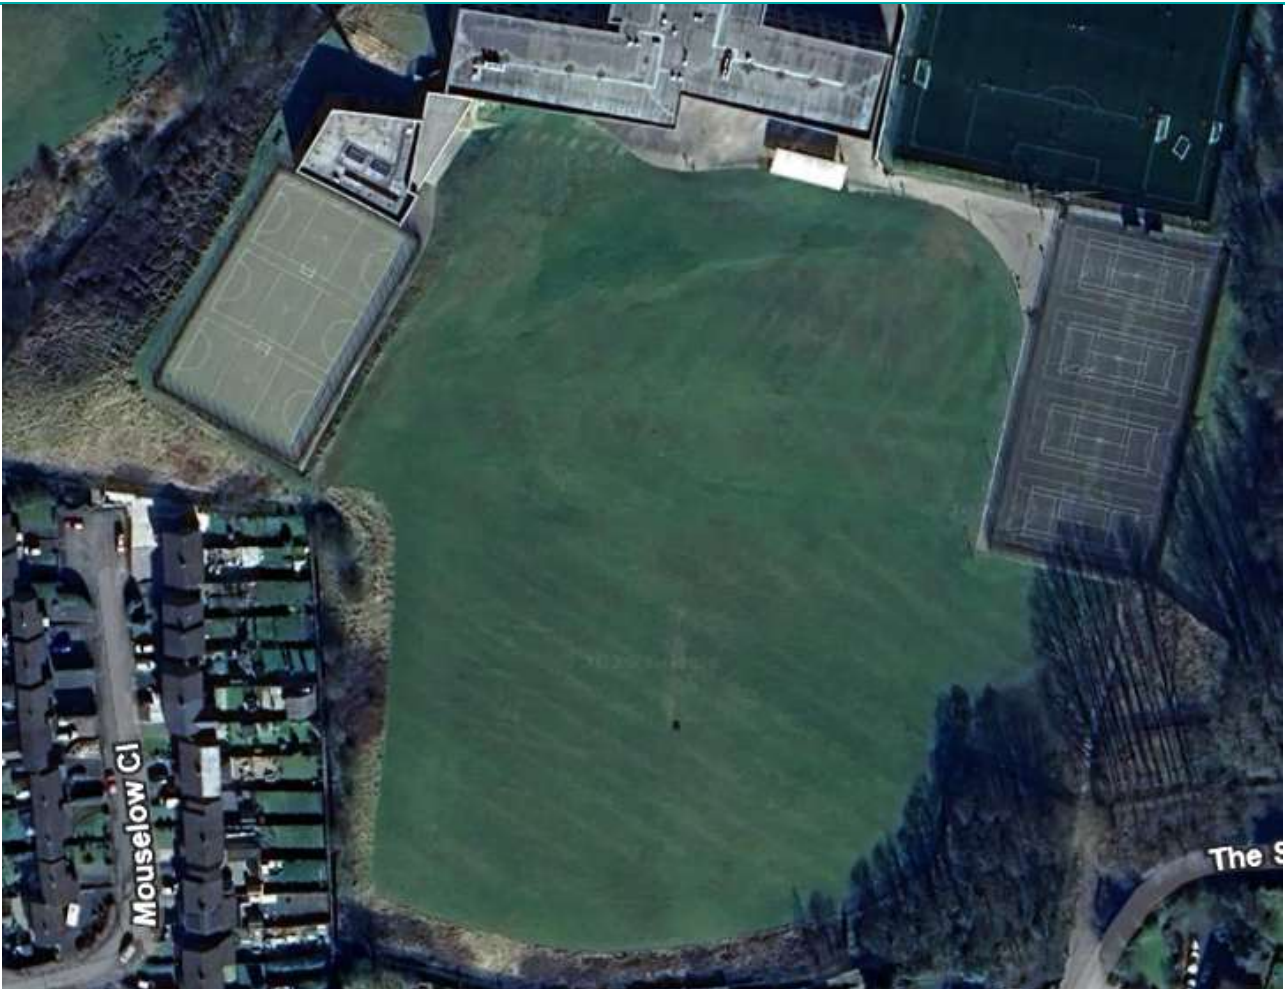
**Figure 8 – Google Earth image dated March 2025 of southern field showing pipe drainage lines at approx. 6m spacings. These same lines are apparent in a Google Earth image dated 2003 – see below.**

The imagery indicates that a primary drainage system is apparent throughout the field at approx. 6m centres and is historic, dating to pre-2003. Pipe drainage systems become less effective over time, particularly if maintenance has been minimal. A system would be expected to have a ~20-25yr effective lifespan if suitably maintained. In addition, following further site development and construction of new artificial pitches, it is highly likely that some of the system was compromised. The school PE staff (Leanne Pace) confirmed to the client that there had not been any drainage installed in the past 18 years whilst she had been at the school.

- A CCTV drainage survey is recommended from the existing manhole chamber located within the north-west corner of the site to establish the condition, connectivity, and eventual outfall location of the existing drainage system. This information will help inform any future drainage improvement works, with any proposed new primary drainage system likely to either connect into the existing manhole arrangement or bypass the existing system through the installation of a new chamber at an appropriate location.

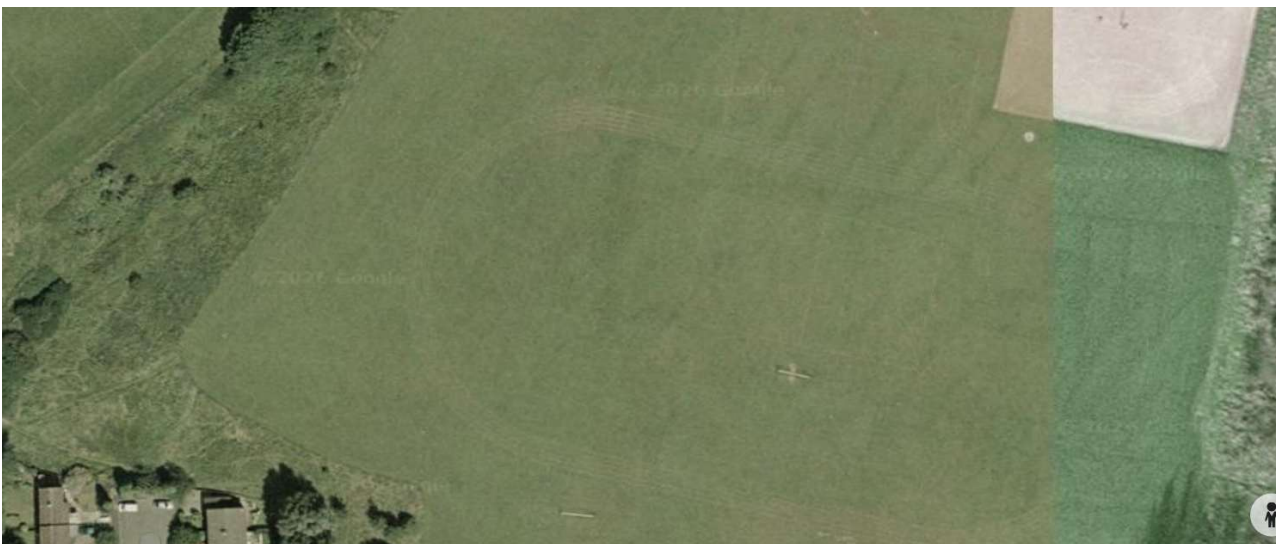
**Figure 9 – Google Earth image dated 2003 showing same pipe drainage lines at approx. 6m spacings. However, further development of the site to include a larger 3G on the east side and a new MUGA of the west side would likely have disrupted the existing pipe network.**

- It was noted that a historic primary drainage system is apparent across the field area. However, based on client feedback and Google Earth imagery, it is understood to be >20yrs old and is at the end of its anticipated service life. Regarding the winter performance of the field, it is considered that surface water is not effectively reaching or being removed through the existing drainage system.

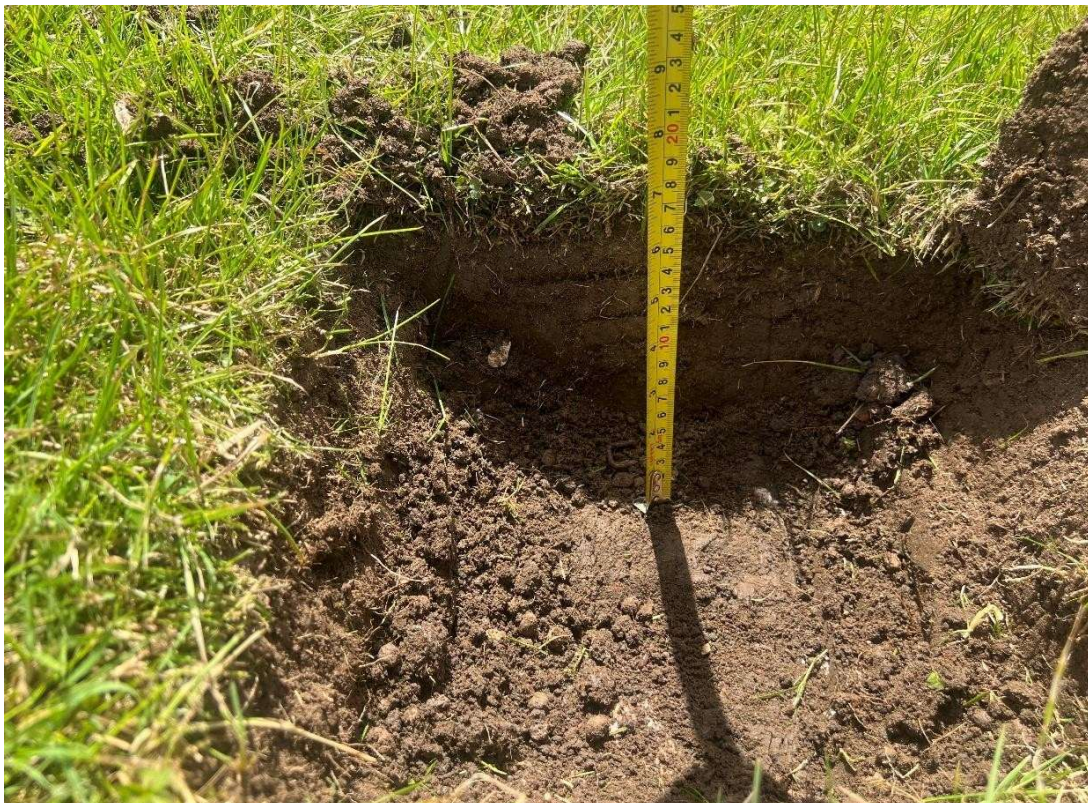
**Photo 4: Excavated trial pit**

The topsoil was observed to comprise a brown, compact clay silty topsoil, overlying a brown clay subgrade. The topsoil and underlying subsoil are considered to exhibit poor drainage characteristics due to their cohesive nature and limited permeability. The average measured topsoil depth was approximately 180mm, with a moderate stone content observed. No stones exceeding approximately 32mm in diameter were recorded within the topsoil layer. Rooting was observed to extend to a depth of approximately 80mm. No contaminants were identified during the inspection, with no evidence of inclusions such as glass or pottery noted.

- A visual assessment of the underlying soil conditions was undertaken through the excavation of a trial pit within the playing field area. The trial pit identified a clay silt soil profile with some medium stone content; however, no significant large stones were observed.

- Due to the inherently poor drainage characteristics of the existing soil, it is recommended that any new primary drainage system is supported by a secondary drainage system in the form of sand/gravel slits. These secondary drainage measures would assist in improving surface water movement through the upper soil profile and provide additional drainage capacity across the playing field area to support winter sports usage.

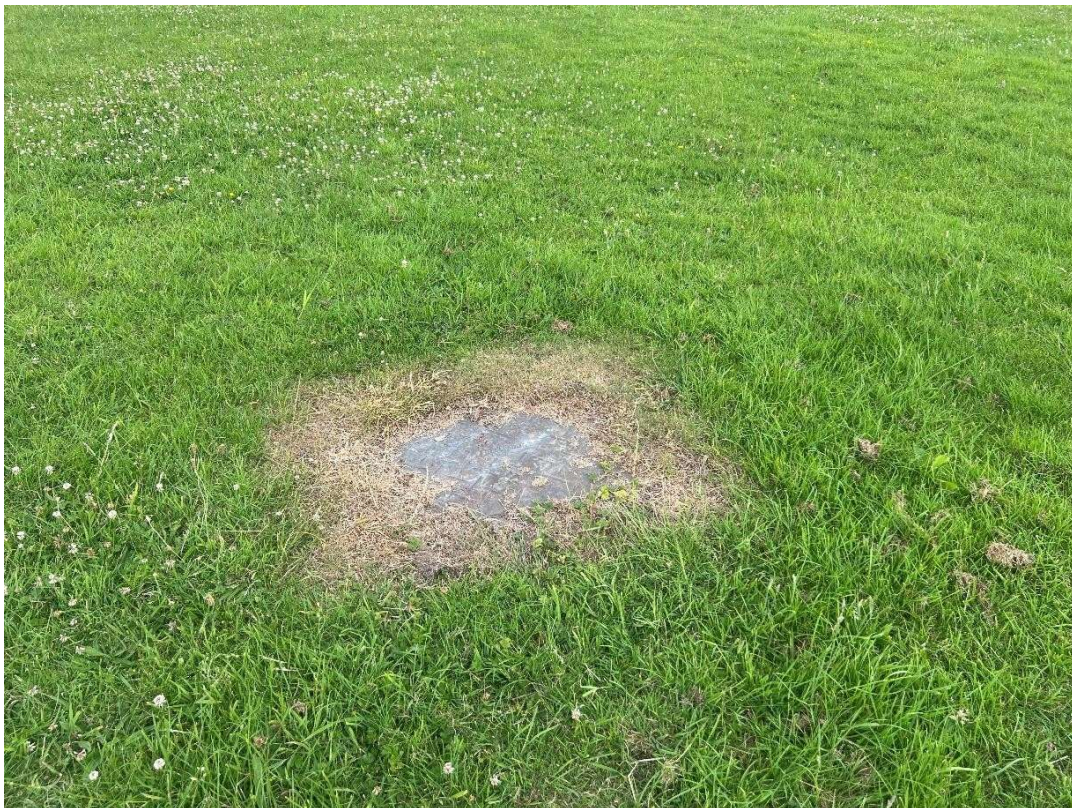
**Photo 6: Manhole cover**

A manhole chamber was also identified within the north-west corner of the site, which is considered likely to be the outfall for some of the drainage system. The manhole was not opened during the site visit; therefore, the condition, configuration, and connectivity of the existing drainage system could not be confirmed at this stage.
