**VULCAN  
INSPECTION  
SERVICES**

**CONTROL OF SUBSTANCES HAZARDOUS TO  
HEALTH (COSHH) REGULATIONS 2002  
REPORT OF THOROUGH EXAMINATION AND TEST  
BY A COMPETENT PERSON OF LOCAL EXHAUST  
VENTILATION EQUIPMENT  
TO MEET THE REQUIREMENTS OF REGULATION 9.(2)**

3 *Location of local exhaust ventilation (LEV) plant.* **Waste Product Warehouse**

LEV 2

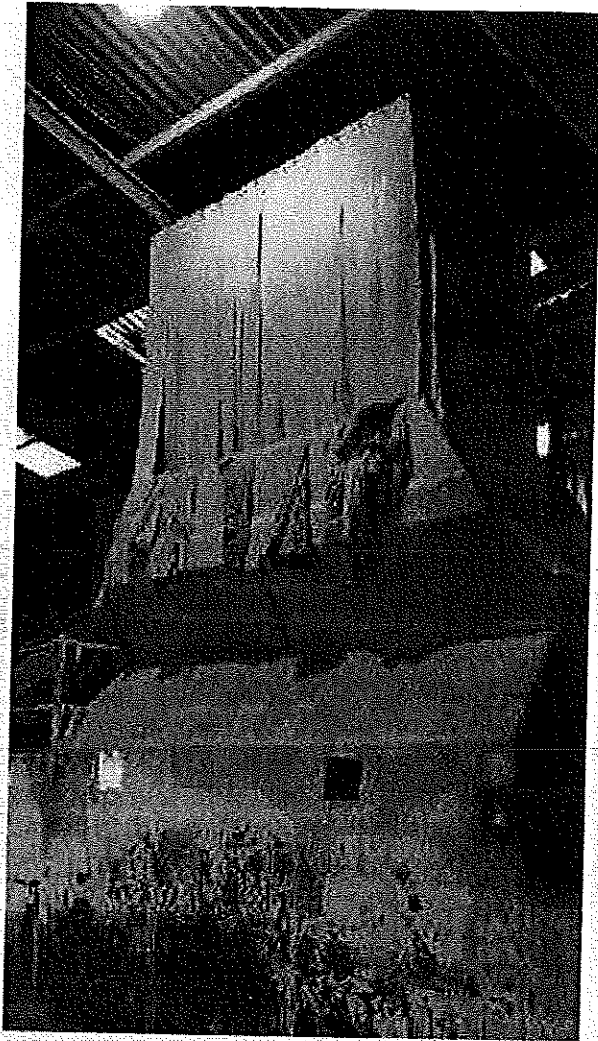
**Emptying Hopper**

A smoke test was carried out at the viewing slot which showed the air being drawn in thus a negative pressure in the hopper area.

The readings for the emptying hopper was taken at the picking area viewing slot with all the doors closed and the internal fan switched off. The hopper was situated at high level and loaded by machinery.

The hopper duct connects to the main duct on a 90 degree angle. This is not recommended as it reduces the extraction flow to this point.
