**HOLEHOUSE
CONSERVATION AREA
CONSERVATION AREA APPRAISAL**

ADOPTED OCTOBER 2010

Prepared by:
Kathryn Sather & Associates
Heritage Conservation Consultants
87 Oldfield Road,
ALTRINCHAM
WA14 4BL

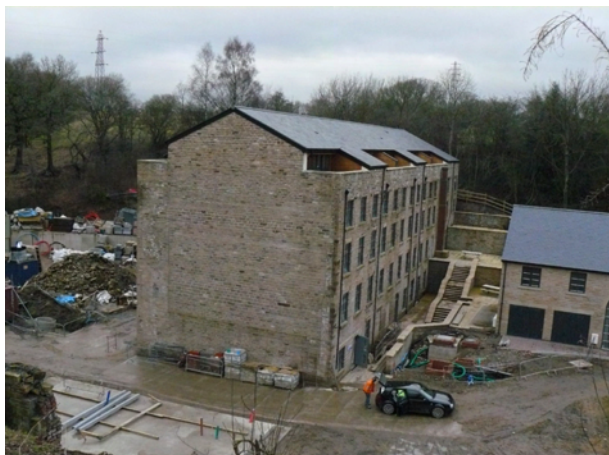
Figure 3 Kinderlee Mill

4.14 Carding and spinning mills were built along water courses in the valley to house these new machines. Kinderlee Mill, near to the Conservation Area, was built in 1804 by the Harrison family, Benjamin Harrison being in the directories of 1835 and 1846. The mill was extended before 1878. The sudden increase in employment opportunities resulted in a massive increase in the local population and in houses built for them. Local quarries, such as that at Combs, provided stone for building and roofing.

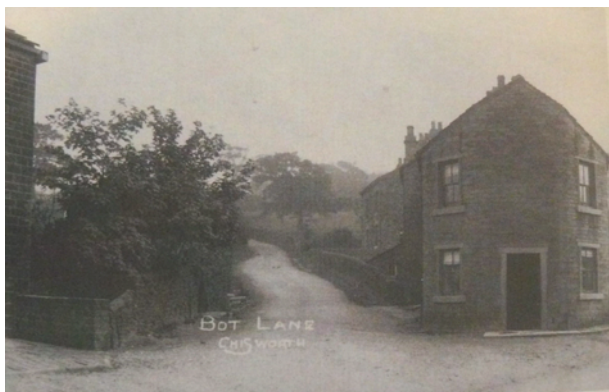
Figure 4 Toll Bar Cottage

4.16 The turnpike road from Marple Bridge to Glossop was constructed in 1803, linking the mills along the valley bottom, and is now the Glossop-Marple Road. The toll bar was located by the junction with Bot Lane (now New Mills Road) and had windows set into angled walls to enable good views down the road so that the keeper could assess the appropriate charge for vehicles.

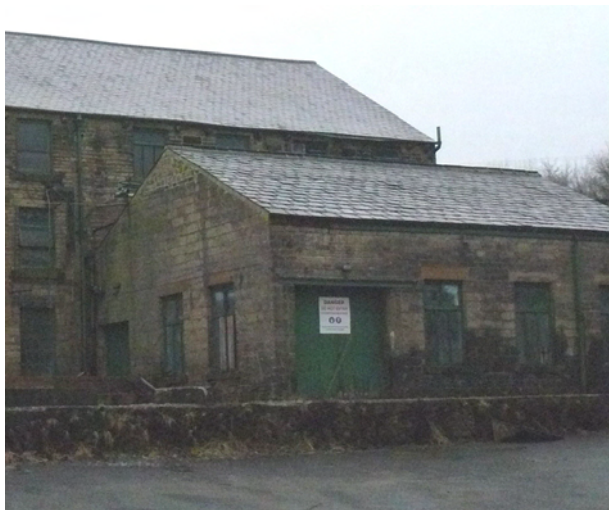
Figure 24 Late 19th Century Extension

4.38 The Mill changed hands after a boiler explosion at Higher Mill in 1889 but was still being used as a bleach works. By 1897, there was a building with a square footprint at the north-eastern end of the main building, which probably equates to the present single-storey 4-bay building, and the vat had been divided into three tanks.

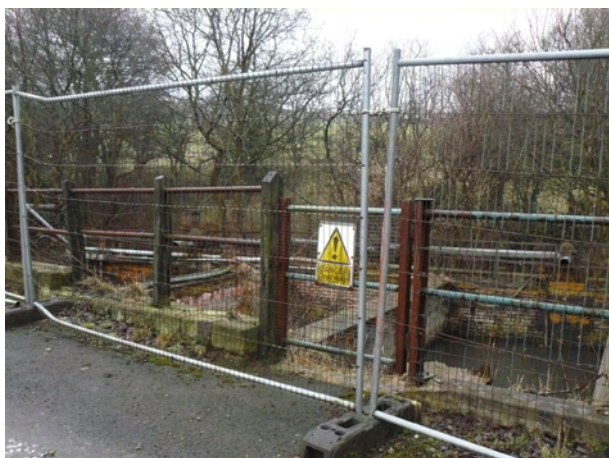
Figure 25 Bleaching Tanks, late 19th Century

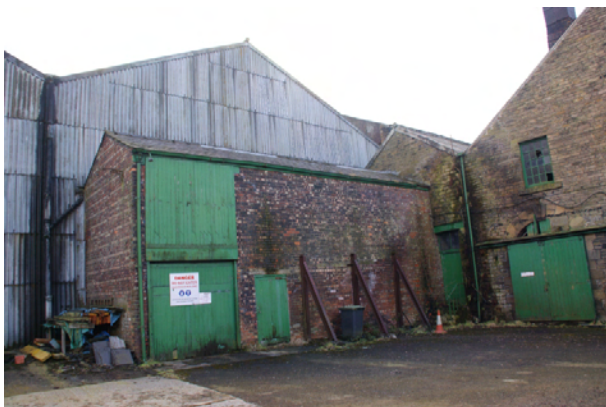
Figure 26 Early 20th Century Extension at North-eastern End

4.39 By 1919, the structure with a square footprint at the north-eastern end had been extended into a more substantial building to fill the gap between the main building and the adjacent building. This equates to the present single storey brick building.

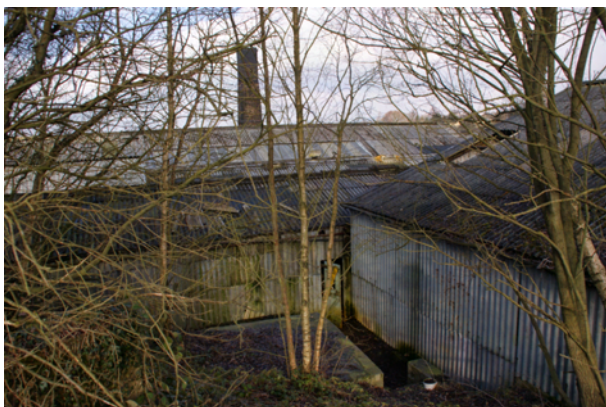
Figure 28 Rear Elevation of 20th Century Extension

4.40 By 1973, the site was used as a dyeing works and there was a large T-shaped extension at the rear which appears to have been added in two stages. The building at the north-eastern end had gone and any gardens in front of the cottages had been covered over for the yard. The only change ten years later was the construction of a square loading ramp at the front. The outline today is the same as it was in 1984.

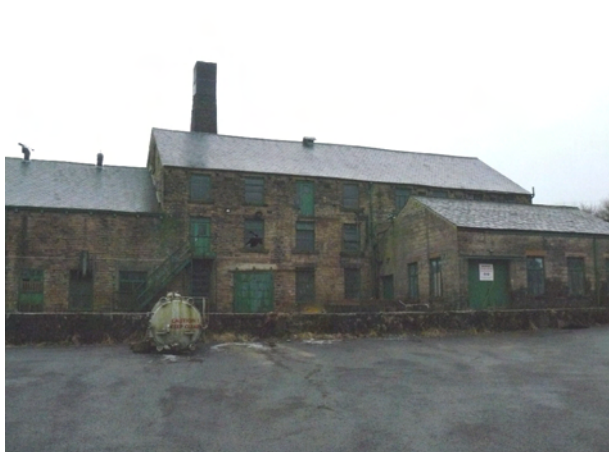
Figure 41 Chisworth Works

4.55 Most of the buildings in the central part of the hamlet and at Fattingley were built as houses for mill workers, generally as terraces. Chisworth Works was built as a cotton mill and is one to three storeys in height. The Works has also had extensions added in the late 20th century to provide additional space for light industrial use.

4.59 Two storeys is the normal building height and two to three bays the normal massing but there are exceptions. The mill buildings of Chisworth Works are three storeys in the older parts with single-storey extensions.

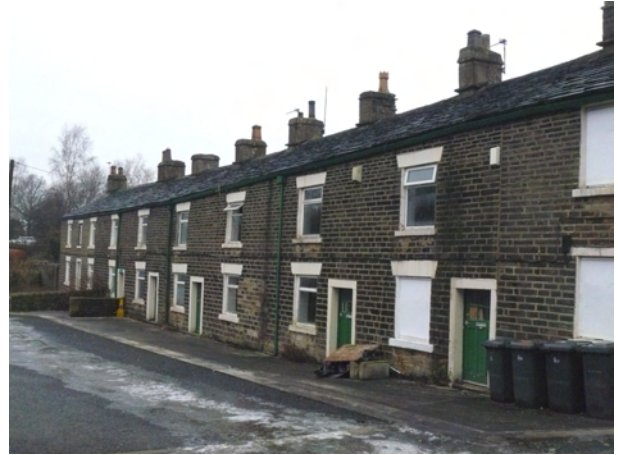
Figure 45 Long Terrace at Chisworth Works

4.58 Buildings have developed along the linear routes of Marple Road and New Mills Road in small groups of terraces with larger detached and semi-detached buildings on the periphery of the area. There is a long terrace of nine houses in the yard at Chisworth Works. The Conservation

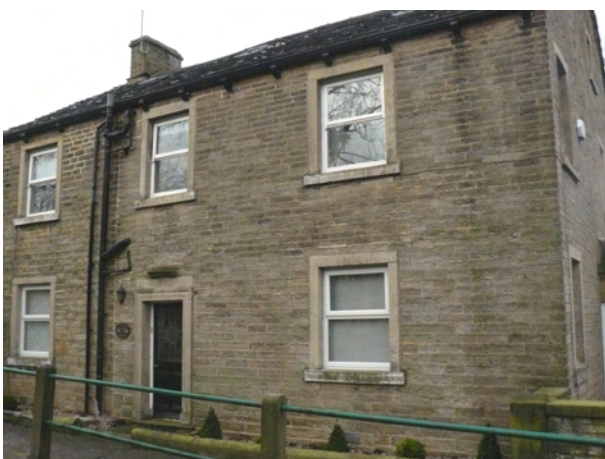
Figure 46 Chisworth House

4.60 Most buildings are vernacular and there is generally little architectural decoration. Most of the terraced or semi-detached houses have plain ashlar window surrounds or window heads and sills and plain ashlar door surrounds. A notable exception is Chisworth House, which has a moulded ashlar door surround with a decorated lintel.

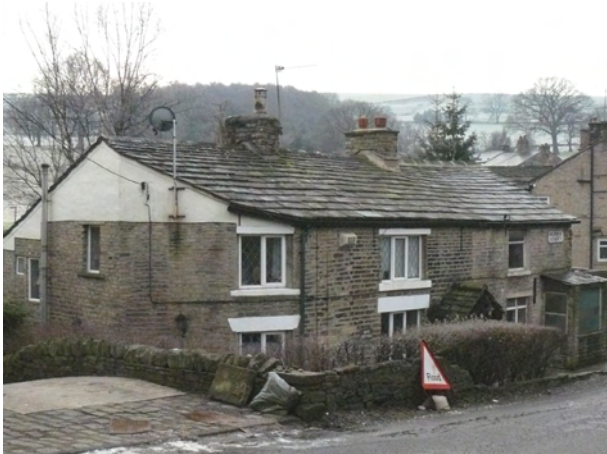
Figure 47 Gritstone Building

4.61 The main building material in the Conservation Area is local gritstone with gritstone dressings and details. Several of the buildings have rendered gable ends.

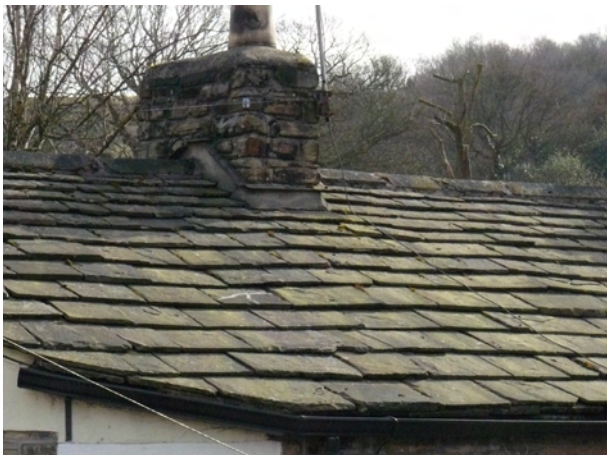
Figure 48 Stone Slate Roof and Chimney

4.62 Roofs on earlier buildings are generally covered with local gritstone slates and those of later buildings with blue slates. Gritstone slate roofs have been identified at the following addresses:

4.63 No replacement roofs of modern concrete tiles or slates of a lighter colour were identified. Chimneys are generally in stone with clay pots, although some have been rendered and some capped.

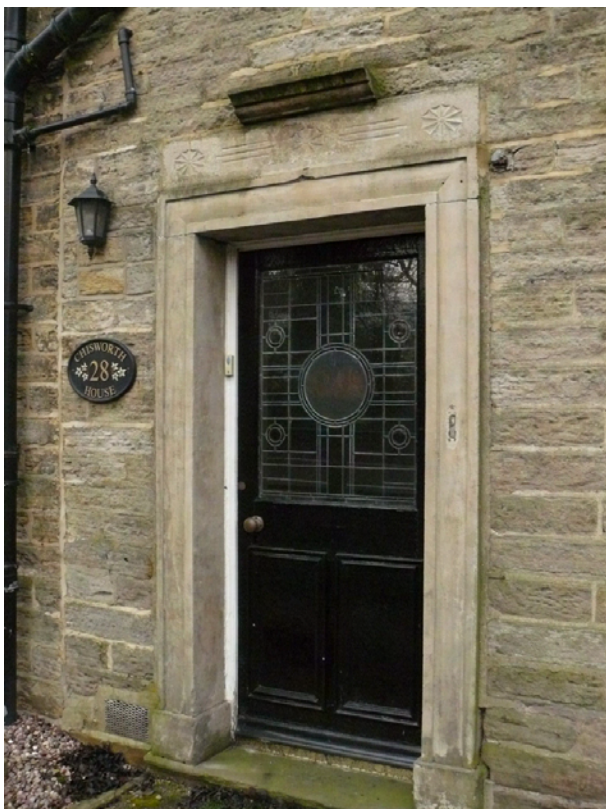
Figure 49 Door of Chisworth House

4.64 Window and door joinery in the Conservation Area's historic buildings was invariably in timber although this has often been replaced with uPVC to the detriment of historic character and appearance. The building stock varies in date from the early 18th century to the late 20th century. Buildings dating from the late 18th century to the 19th century would have featured sliding sash windows: those built before around 1850 without horns, those afterwards with horns (an extension of the vertical part of the frame of the upper sash to provide additional support for the window). Chisworth House, which pre-dates 1857, has an original single leaf wooden door which is part-glazed with original leaded glass.

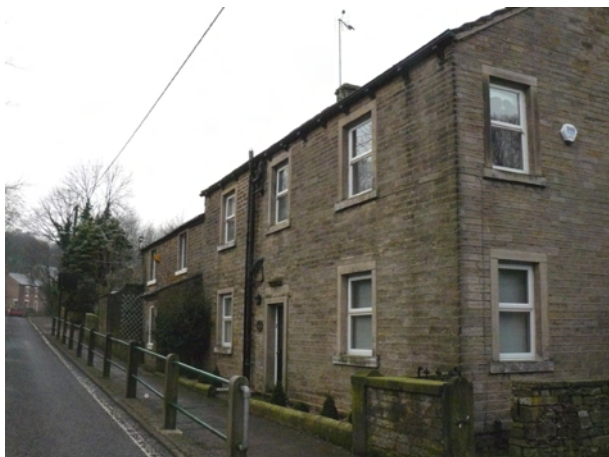
Figure 50 Low Stone Boundary Wall at Chisworth House

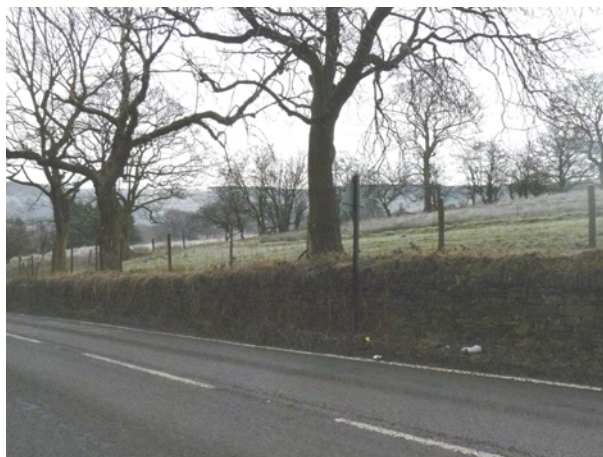
Figure 51 Stone Field Retaining Wall

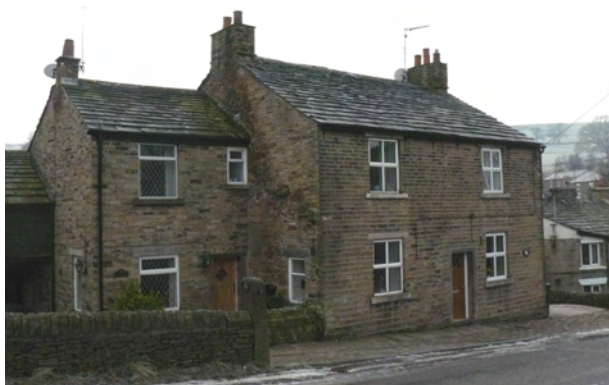
Figure 52 Cobbles Outside 65-67 Marple Road

4.67 Street surfaces are entirely of tarmac, as are most pavements, with concrete kerbs. There are original cobbles outside 65-67 Marple Road and stone flags outside 112 Marple Road. There are also what may be replacement cobbles outside 11 Marple Road. There is little street furniture but some is of poor quality, such as inappropriate concrete kerbing and metal railings outside numbers 28-30 Marple Road. Heavy traffic is having a detrimental effect on the character of the village.

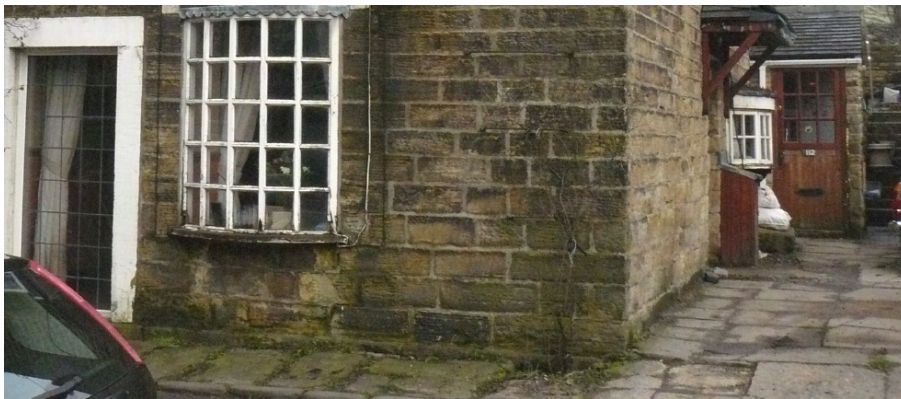
Figure 53 Stone Flags Outside 112 Marple Road

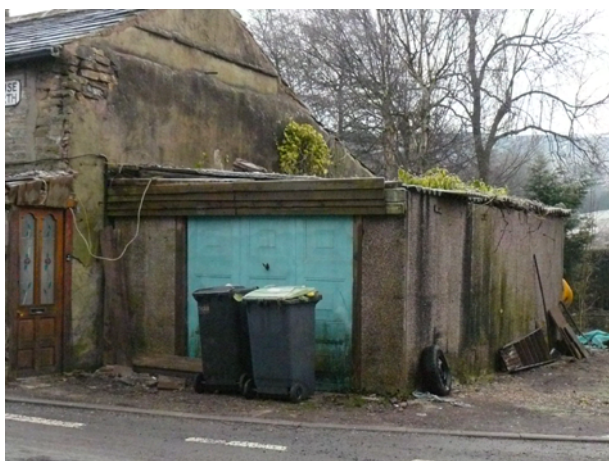
- Many buildings are fitted with replacement windows in inappropriate modern styles and materials.
- An intrusive garage by number 5 Marple Road is out of keeping with the character of the rest of the designated area. The south-west wall of the cottage is also in a poor condition.

Figure 57 Intrusive garage at 5 Marple Road

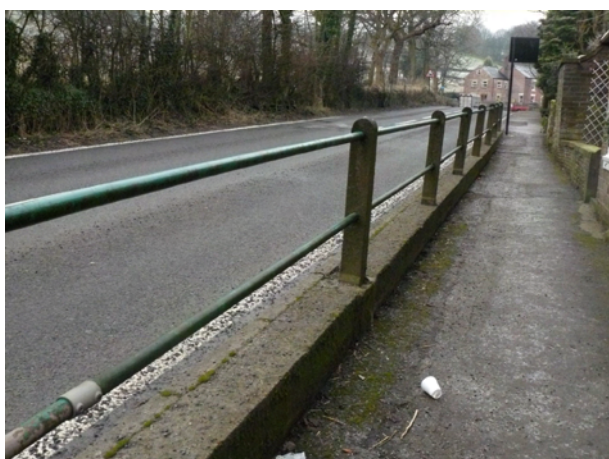
- The concrete kerbing and metal railings outside numbers 28-30 Marple Road are of inappropriate materials.

Figure 58 Concrete Kerbing and Metal Railings

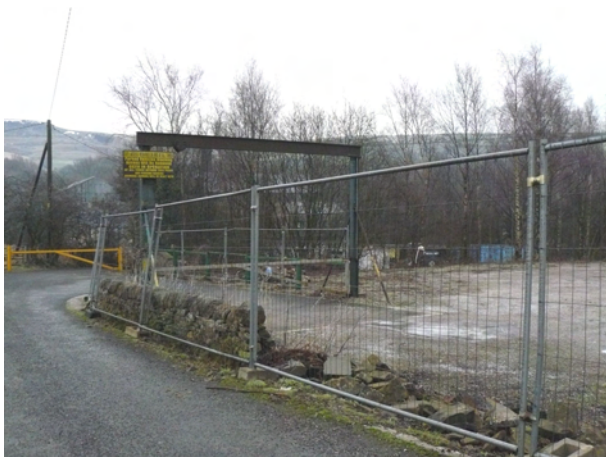
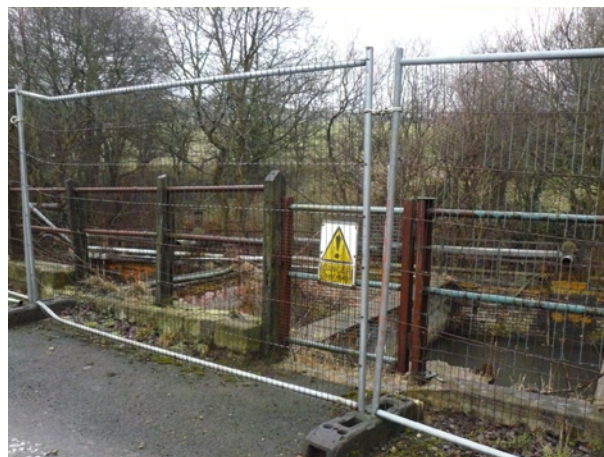
- The metal fencing at the car park adjacent to Chisworth Works and by the bleaching vats is of poor quality and there is an untidy yard opposite the mill.

Figure 59 Intrusive Fencing by Chisworth Works

Figure 60 Intrusive Fencing by Vats at Chisworth Works

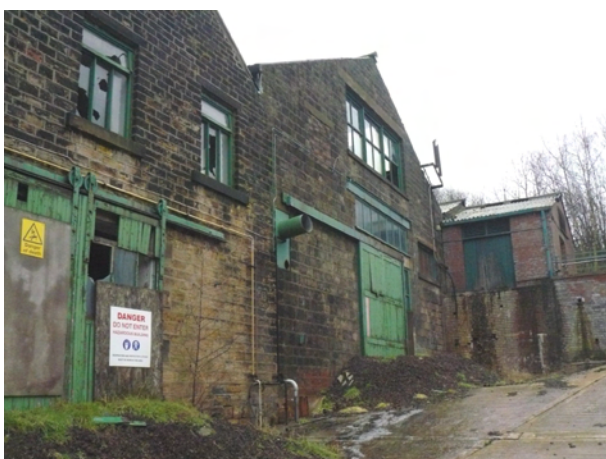
Figure 61 Chisworth Works

4.70 Most properties are in good condition and are well looked after by owners. However, Chisworth Works was largely vacant and the terrace of cottages was also vacant at the time of survey.
