# FORMER GLOSSOPDALE COMMUNITY COLLEGE, TALBOT ROAD PLANNING APPEAL

HPK/2024/0481

PROOF OF EVIDENCE BY STELLA RIXON,  
BSc (HONS), MBPR

Date: 21 July 2026

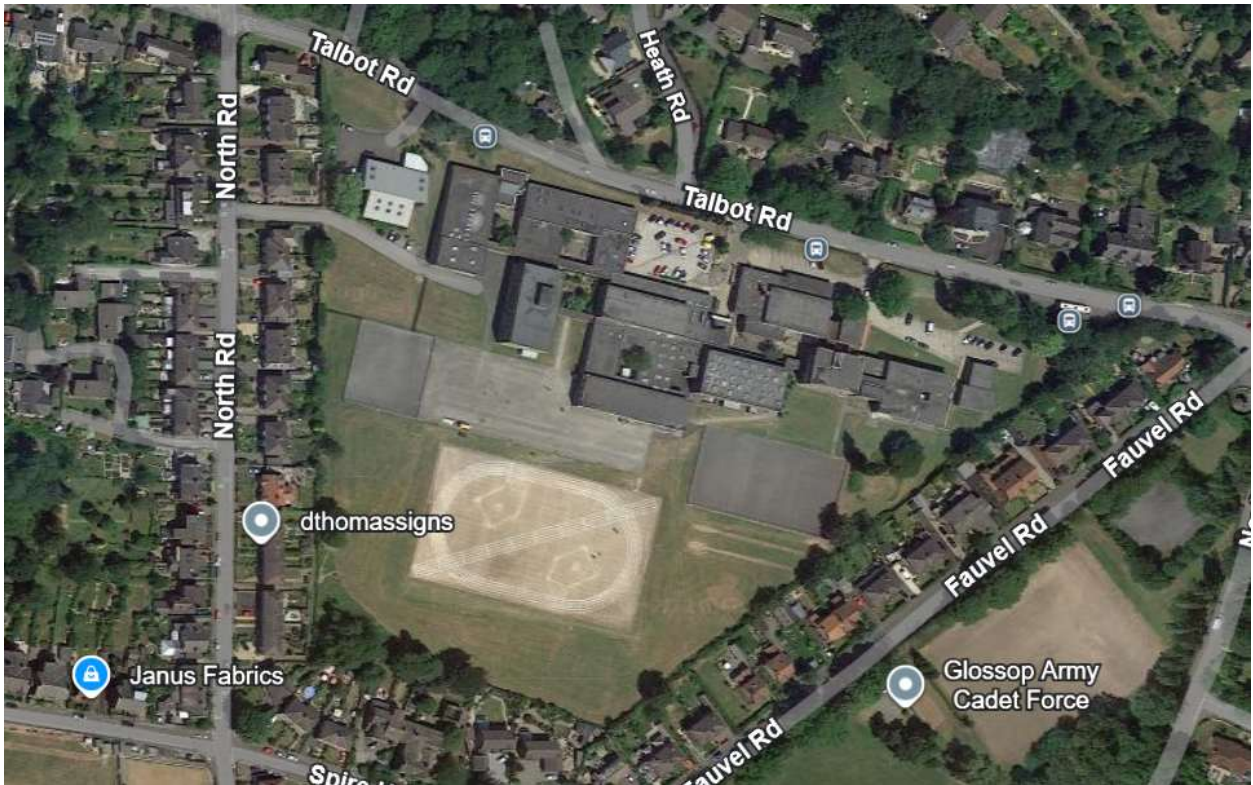
Figure A: Google Earth image dated Jun 2018 of Talbot Rd site when still in use showing the Redgra area in the south with its running tracks and rounders markings, 2 x long jump areas evident on the right side, and some evidence of athletics on the marginal grass areas.

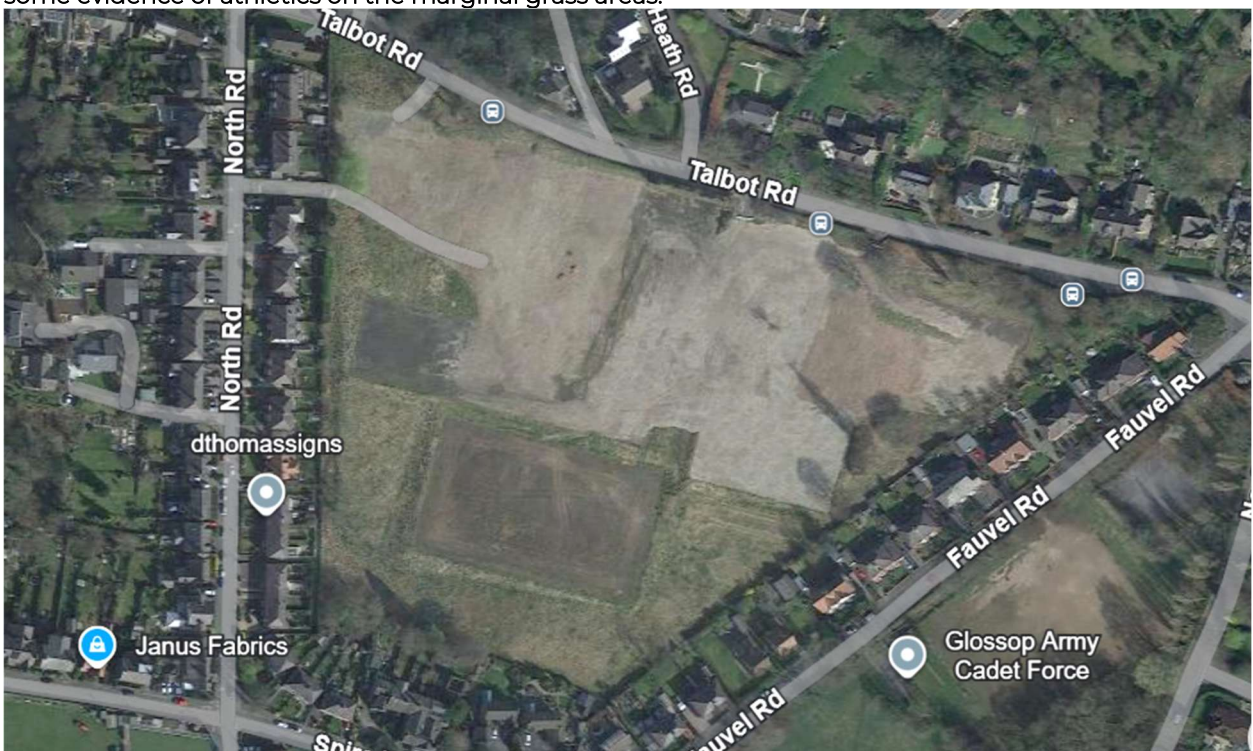
Figure B: Google Earth image dated Sept 2023 of Talbot Rd site post demolition.

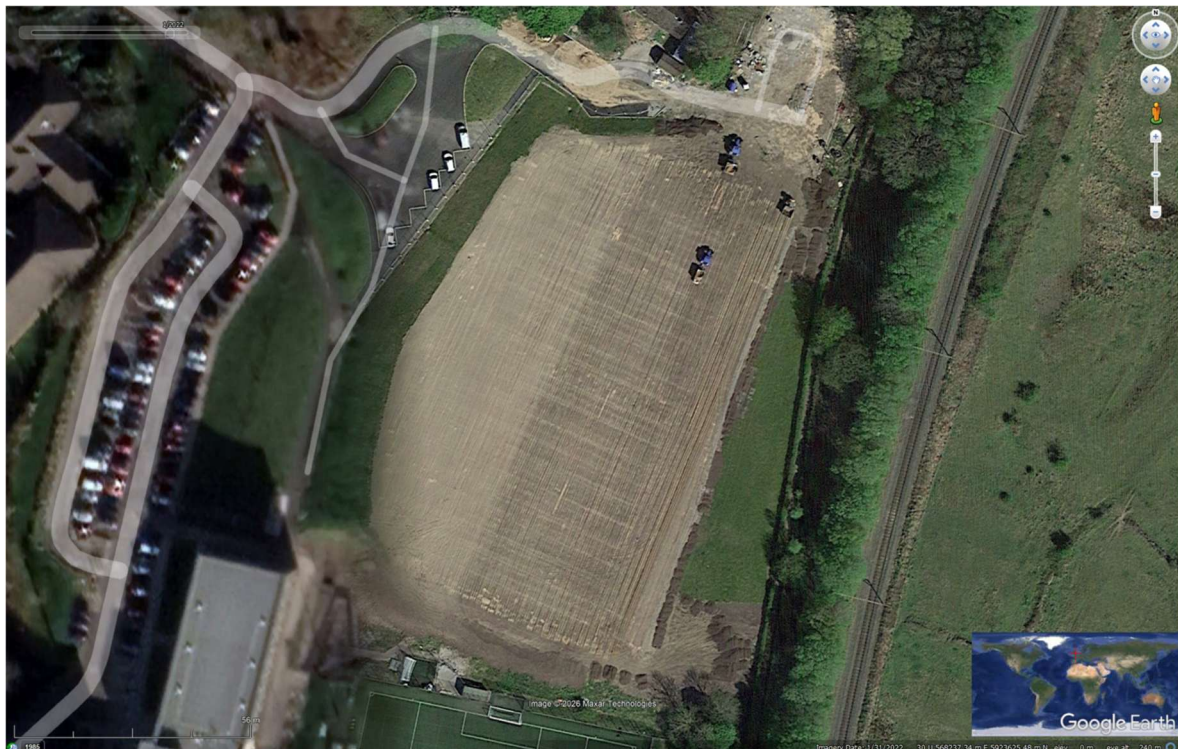
Figure 1 - Satellite imagery taken from Google Earth showing playing field construction. Imagery dated 24/04/2020

The playing fields have subsequently received limited maintenance since construction, ultimately leading to the poor agronomic condition and PQS recorded in the PitchPower report.

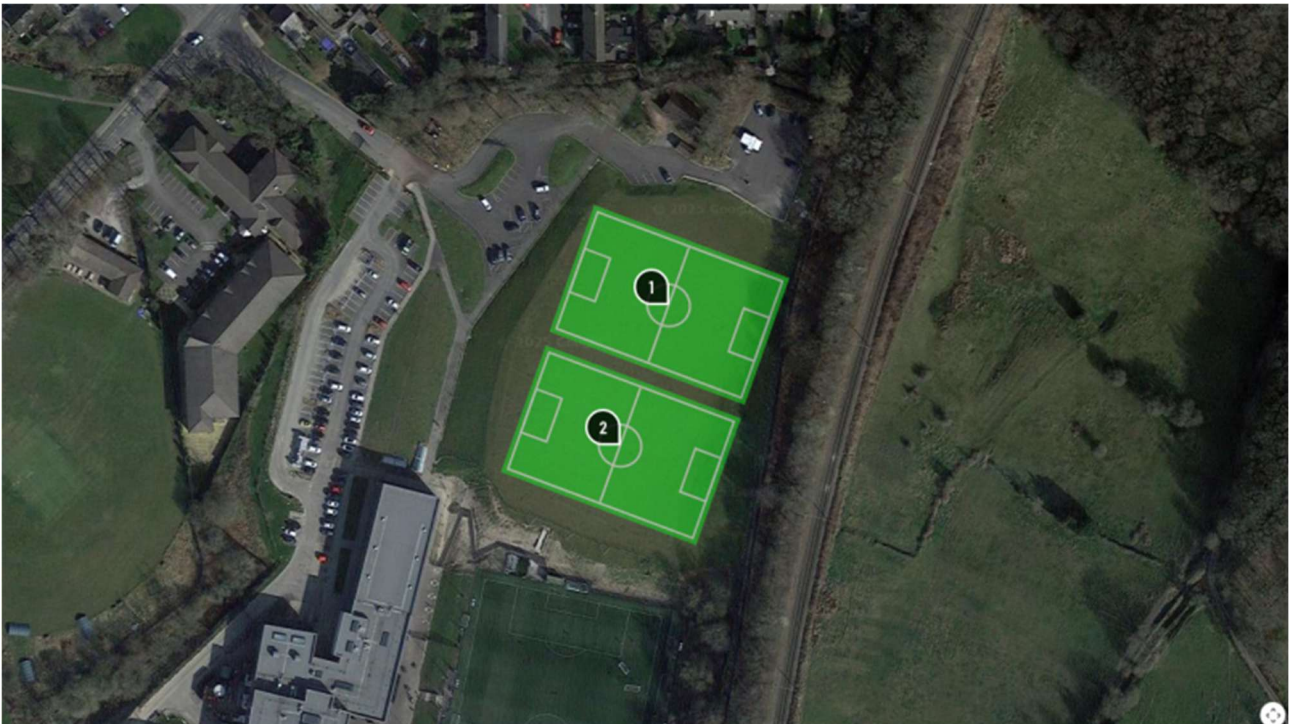
Both of the 9-a-side football pitches contained within the northern playing field were assigned a PQS score of Poor. Pitch 1 achieved a score of 41%, Pitch 2 achieved a score of 30%.

Figure 2 - Image from PitchPower report showing location of both 9-a-side football pitches

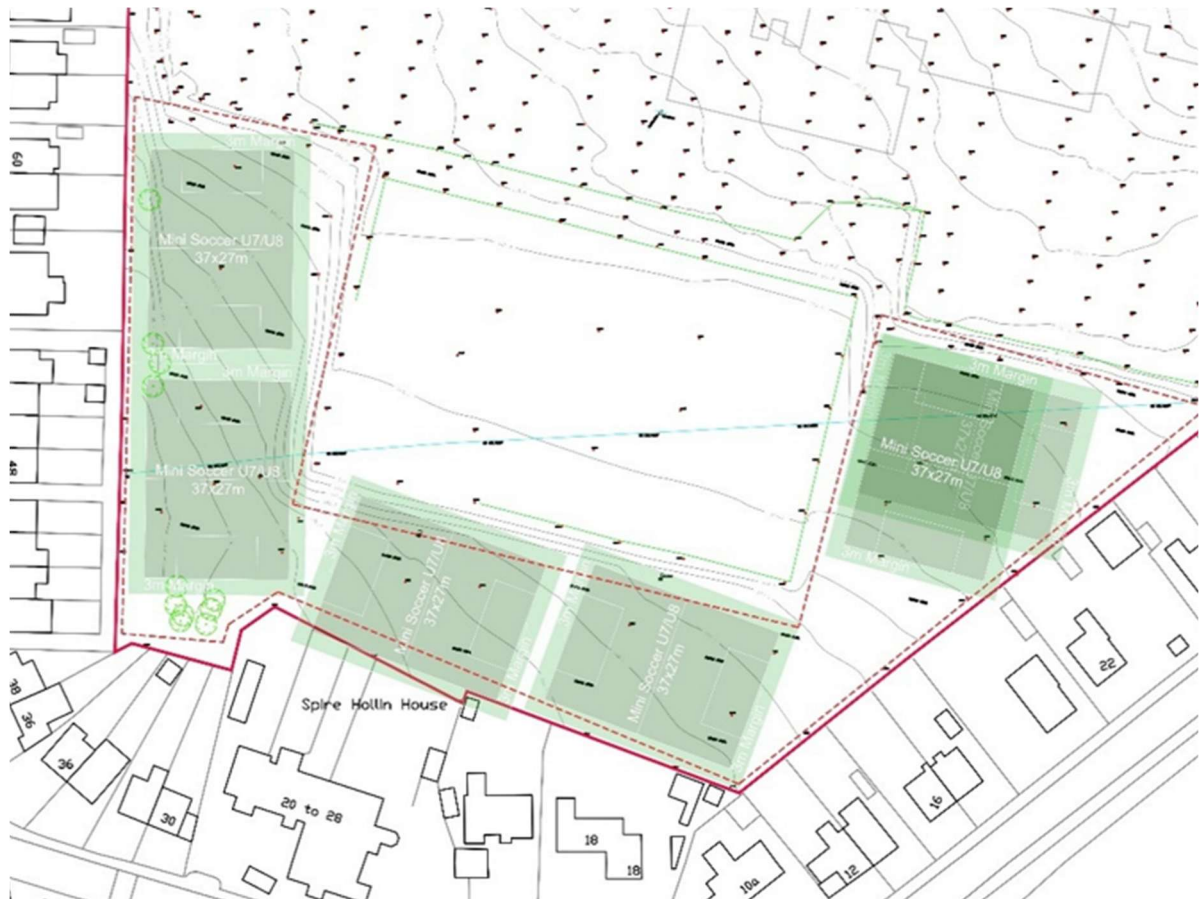
### 3. Talbot Rd site layout plan

As shown in the CAD drawing below, it is only possible to fit a single U7/U8 mini pitch of FA recommended size (including appropriate safety margin run-offs) into the top left (NW) corner around the Redgra surface. However, the topography is non-compliant for sports use.

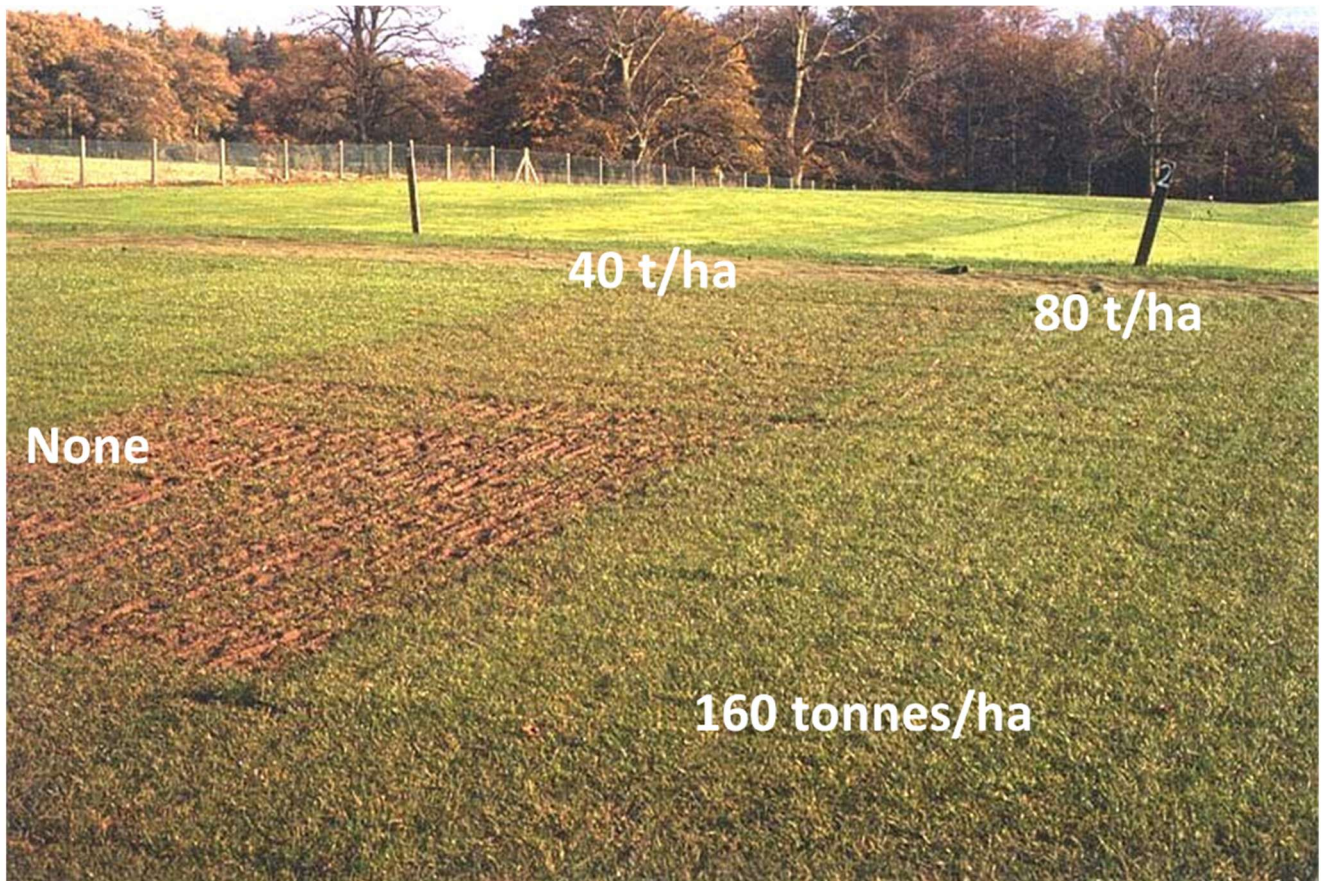
## 5. Importance of Topdressing

The photograph below is from STRI's trials grounds showing the effect of sand topdressing on trial plots of natural sandy loam soil exposed to simulated football use. The sand dressing helps to mitigate for worm casting and protects installed drainage from contamination (fine particles smeared over the top). Common problems for grass roots clubs are budget for sand and quality control (e.g. using the wrong type of sand, particularly cheaper options).

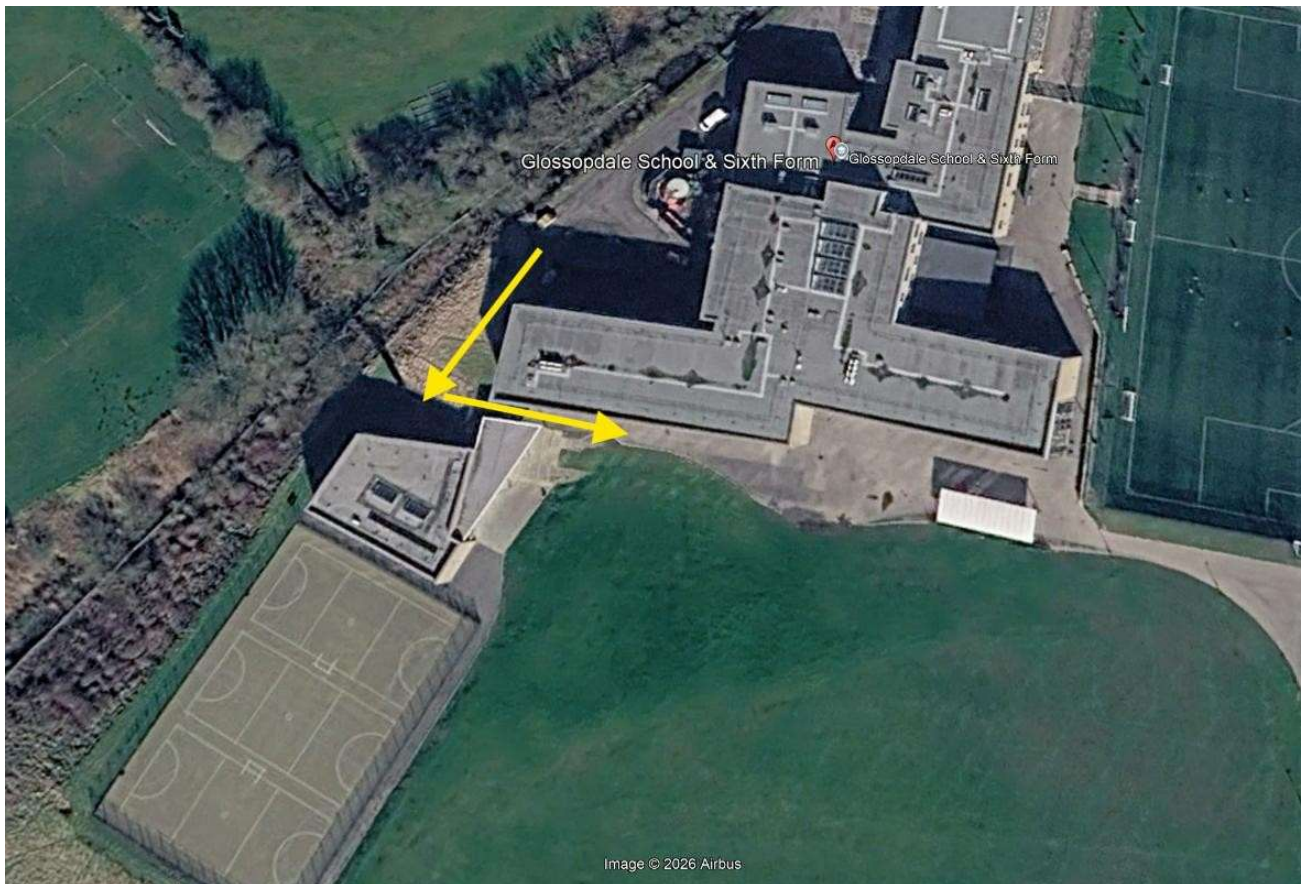
Site access was gained through the main school building at the time of the visit. However, access for maintenance equipment was understood to be gained through the north-west corner of the site, via a gap between the existing school buildings. This route provides access through to the front car park located to the north of the school building.

**Figure 2 – Site access**

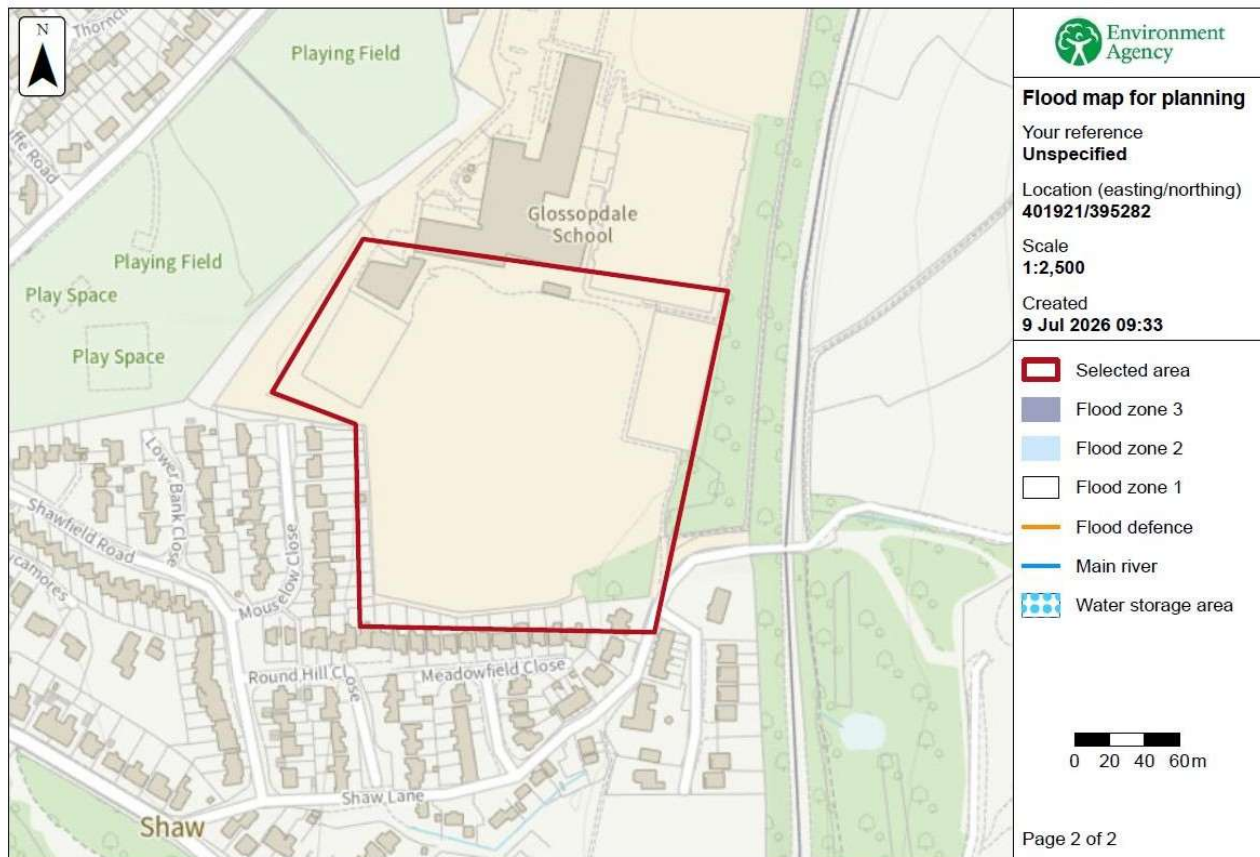
The following information has been obtained from Environment Agency Flood Risk Maps (see Figure 3 and 4). Figure 3 shows that the playing field area is within Flood zone 1 which is very low risk (1:1000 annual chance) of flooding from waterways/ sea. Figure 4 shows the risk of surface water flooding from land run-off. The only area potentially impacted by surface water flooding is the MUGA within the north-west corner of the site. Figure 5 shows predicted surface water flow across the site according to topography.

**Figure 3 – Flood risk – minimal risk**

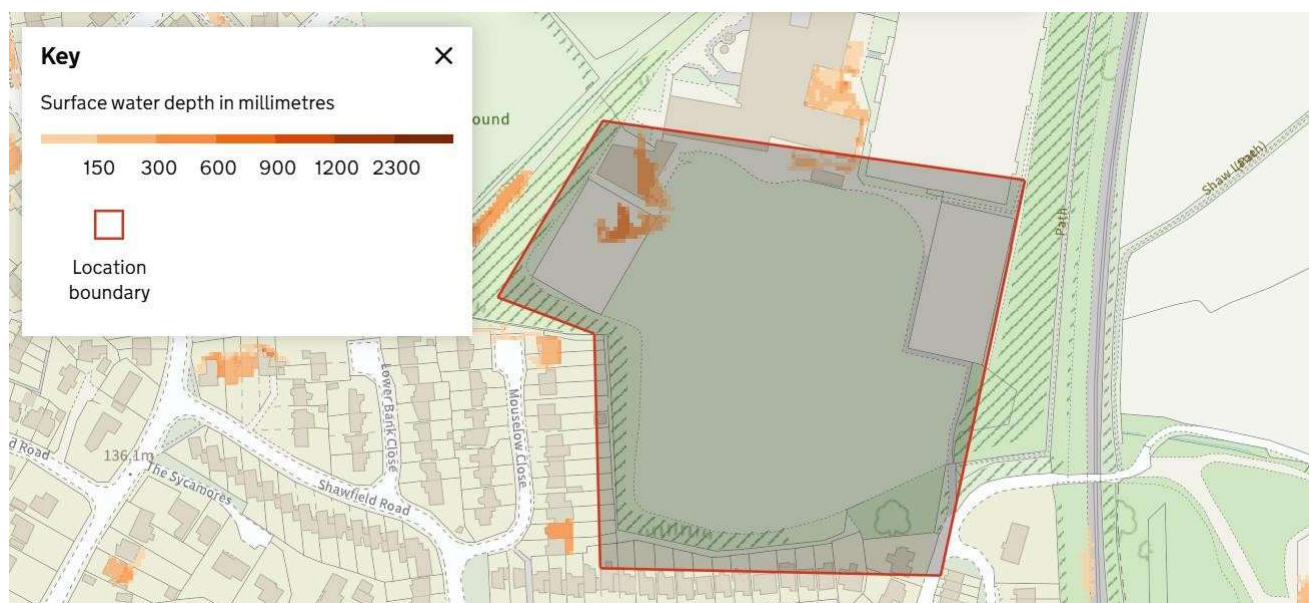
**Figure 4 – Surface water risk of flooding only on the MUGA**

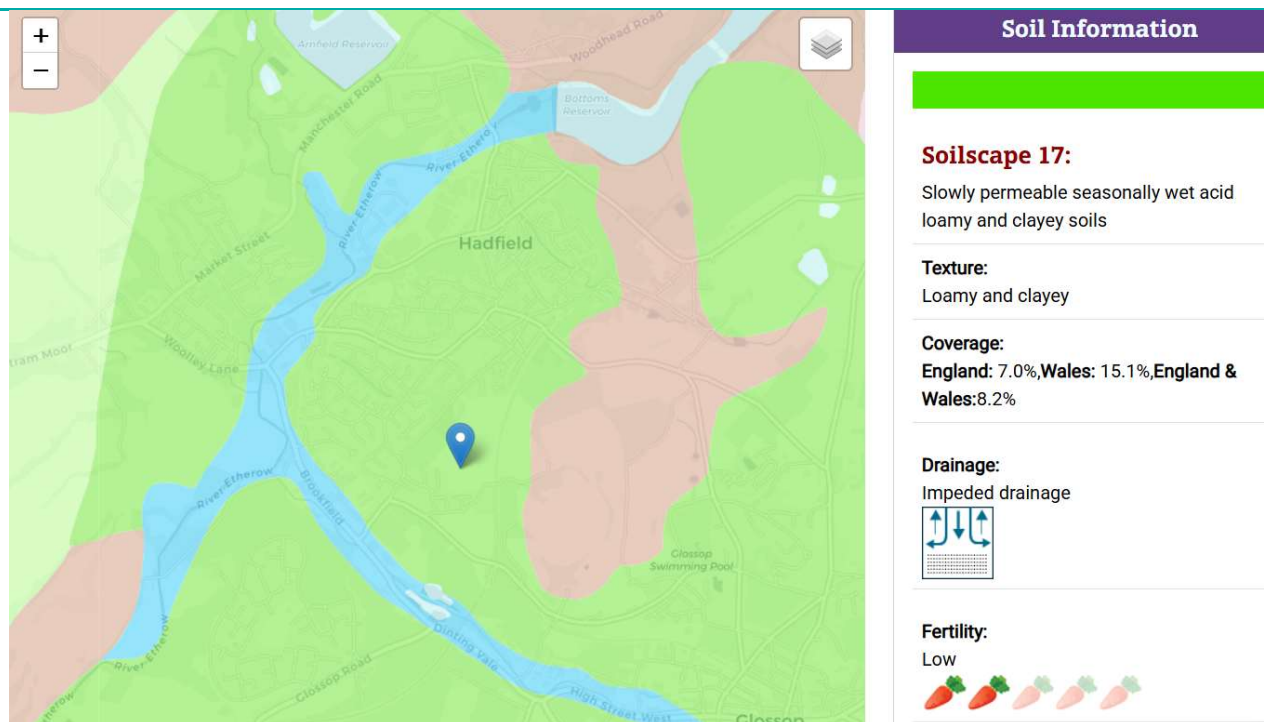
The classification of the soil type via LandIs describes the topsoil as slowly permeable, seasonally wet acid loamy and clayey soils with impeded drainage. Observations on site confirmed this – see 3.5 below.

Figure 6 – LandIS soil map classification for the Glossopdale School site.

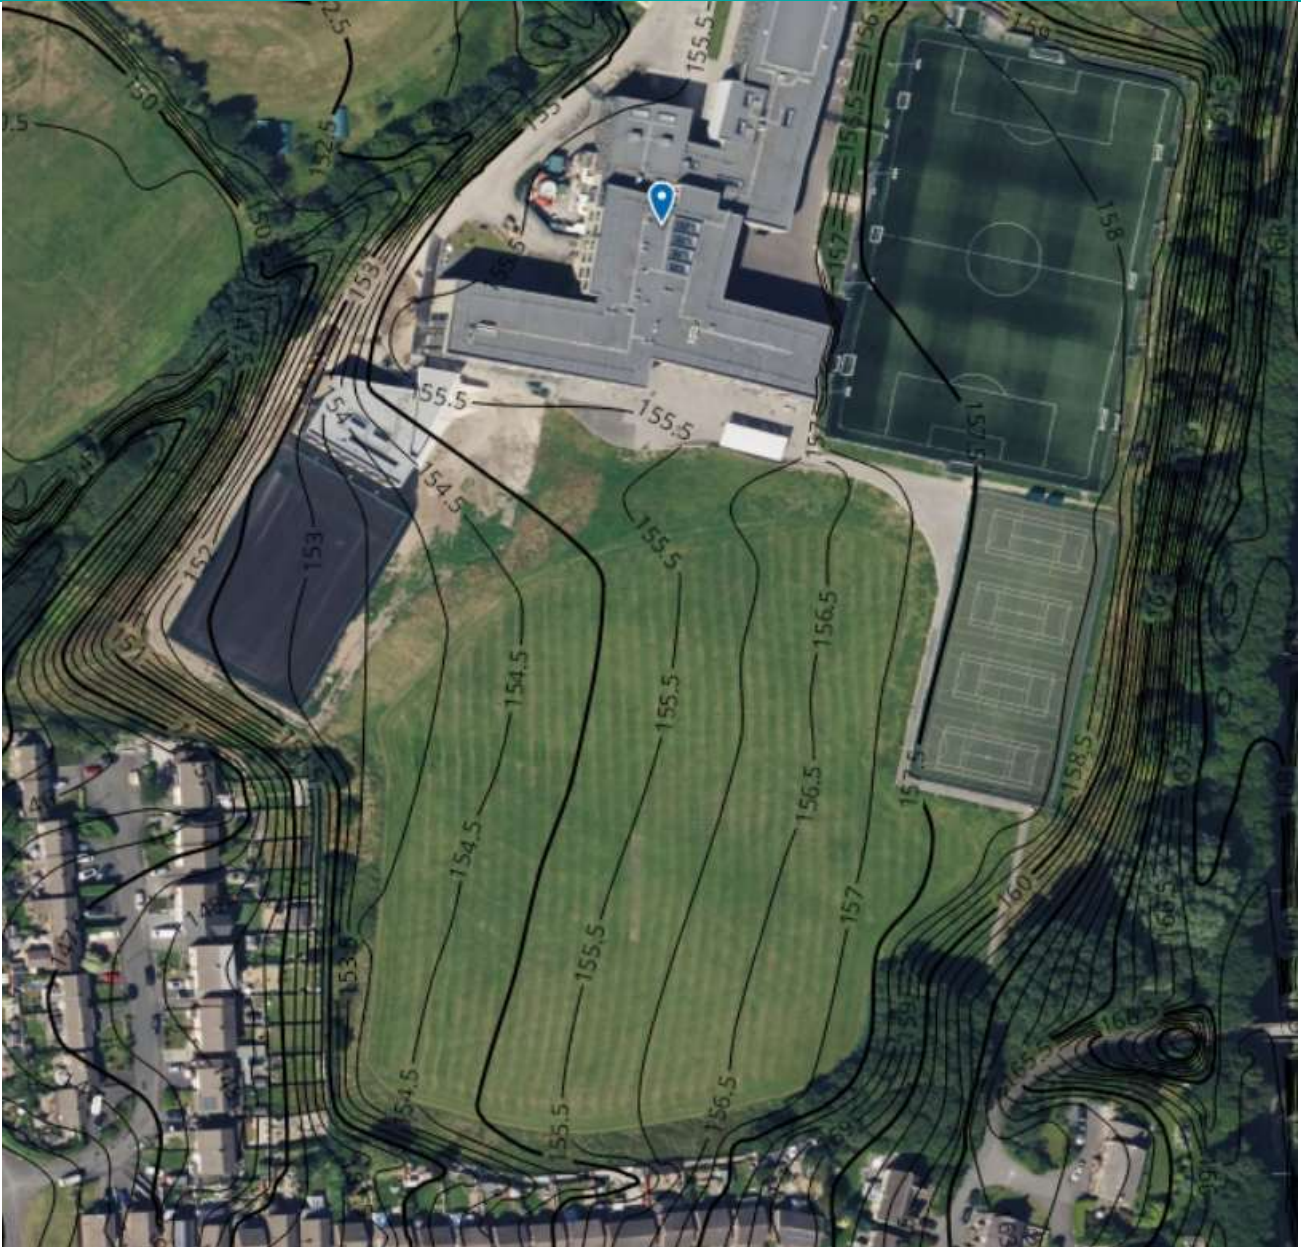
Sport England guidelines recommend that playing surfaces should be no steeper than 1:80 – 1:100 along the line of play and 1:40 – 1:50 across the line of play so as to avoid slope having adverse effect on play, whilst still retaining some fall to assist with drainage. A pitch orientated N-S would comply with the in-the-line-of-play gradient but be just outside of the recommended across-play gradient. However, the Sport England gradient guidelines allow for some slight deviation in areas of high rainfall where slopes might need to slightly exceed recommendations in order to aid drainage.

*Figure 7 – Site topography (obtained from LiDAR data) for Glossopdale School southern field.*

If a winter sports pitch is to be accommodated within the field area, it is recommended that the pitch is orientated north-south to align with the more favourable existing gradients and to support compliance with Sport England pitch gradient guidelines.

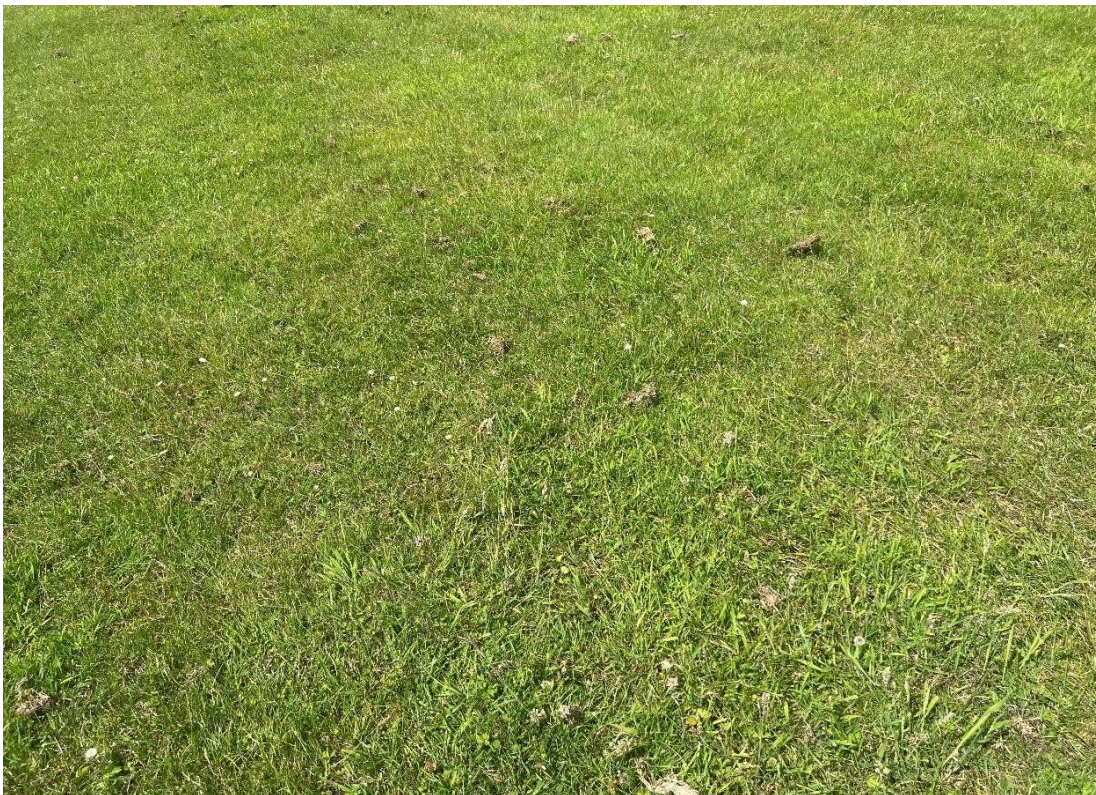
**Photo 2: Vegetation cover**
